# Effects of 45 years of heavy road traffic and climate change on the thermal regime of permafrost and tundra at Prudhoe Bay, Alaska

Buchhorn, M.<sup>1,2</sup> (mbuchhorn@alaska.edu); M.K. Raynolds<sup>1</sup>; D.A. Walker<sup>1</sup>; M. Willis<sup>1</sup>; L.M. Wirth<sup>1</sup>; M. Kanevskiy<sup>3</sup>; G. Matyshak<sup>4</sup>; Y. Shur<sup>3</sup>; and J. Peirce<sup>1</sup> <sup>1</sup>University of Alaska Fairbanks, Institute of Arctic Biology, Fairbanks, AK 99775 USA; <sup>2</sup>University of Alaska Fairbanks, Geophysical Institute, Fairbanks, AK 99775 USA <sup>3</sup>University of Alaska Fairbanks, Department of Civil & Environmental Engineering, Fairbanks, AK 99775 USA; <sup>4</sup>Moscow State University, Department of Soil Science, Moscow, Russia

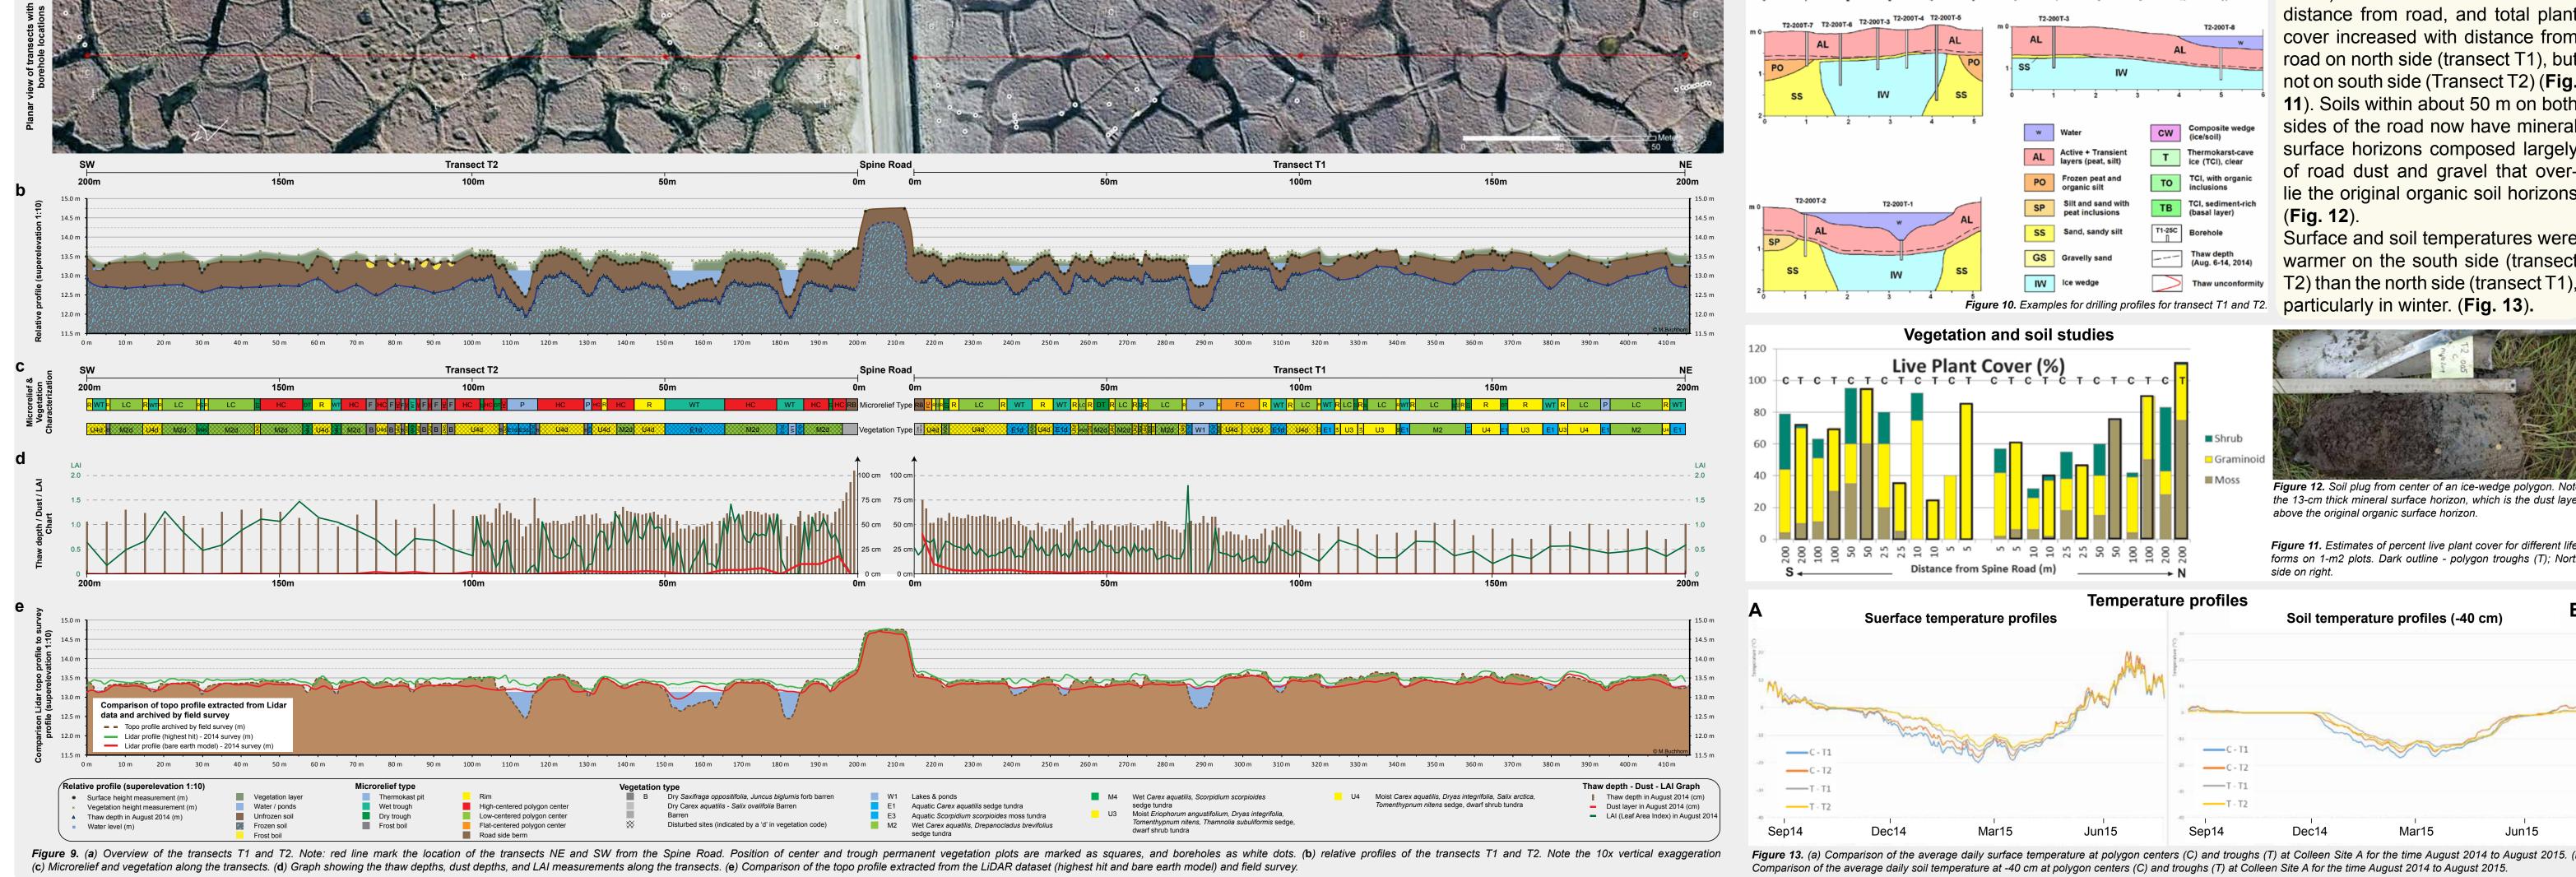
A visualisation of all collected geo-ecological parameters along the transects T1 (north) and T2 (south) at 1 m intervals within 100 m of the road and at 5 m intervals from 100 to 200 m from the road can bee seen in Figure 9. In detail, aerial photography from 2014 is shown at the top of Fig. 9, with cross-sectional transect of surface elevation, vegetation height, thaw and water depth (b); surface geomorphology and vegetation type (c); probed thaw depth, LAI, and depth of surface dust layer (d); and comparison of the field survey to LiDAR data (e). The interpretations of ice-wedge cross-sections based on borehole profiles is seen in **Figure 10**.

Vegetation plots along two transects were set up in polygon centers and troughs at 5, 10, 25, 50, 100 and 200 m from both sides of the heavily-traveled Spine Road at Colleen Site A to analyze road effects. Differential GPS and a robotic TotalStation were used to survey the transects (Fig. 9). Soil and vegetation data were collected at 1 m intervals within 100 m of the road and at 5 m intervals from 100 to 200 m from the road (Fig. 9, 11, 12). Fifty-seven boreholes were drilled in ice-wedge polygon centers and troughs (Fig. 10). One hundred and thirty Thermochron® Temperature Data Loggers (iButtons) were installed to monitor air and ground temperatures and determine ice-wedge stability (Fig. 13).
