Effects of 45 years of heavy road traffic and infrastructure on permafrost and tundra at Prudhoe Bay, Alaska

AGU abstract: GC23J-1215

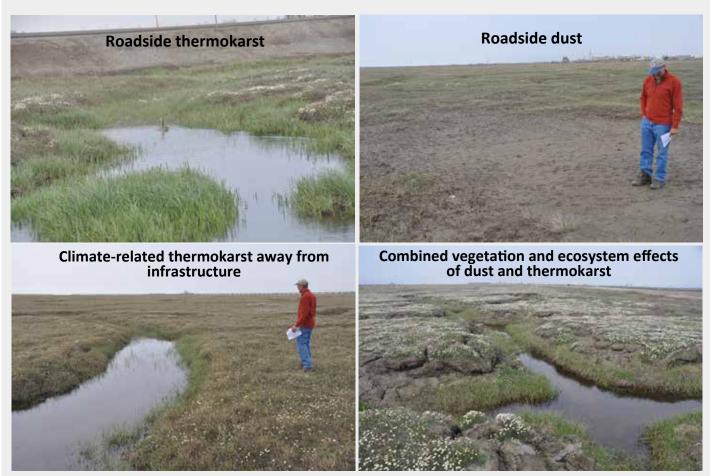
Figure 2. Roadside disturbances related to dust and thermokarst.

Most changes in landscapes along roads are caused by a combination of (a) **flooding** due to the elevated road beds that interrupt natural drainage flow patterns; (b) heavy road dust, which smothers the vegetation and changes the albedo of the tundra surface; and (c) **snow** banks that form along the edges of the elevated roads. All of these factors tend to raise soil temperatures, which in turn increase the active layer thickness near roads, leading to roadside thermokarst (Fig. 2).
