Permafrost-Related Causes and Consequences of the Sagavanirktok River Delta Flooding in Spring 2015

*Yuri Shur¹, Mikhail Kanevskiy¹, Donald A. Walker¹, Torre Jorgenson^{2,1},
Marcel Buchhorn¹, Martha K. Raynolds¹, Horacio Toniolo¹*

¹University of Alaska Fairbanks, ²Alaska Ecoscience

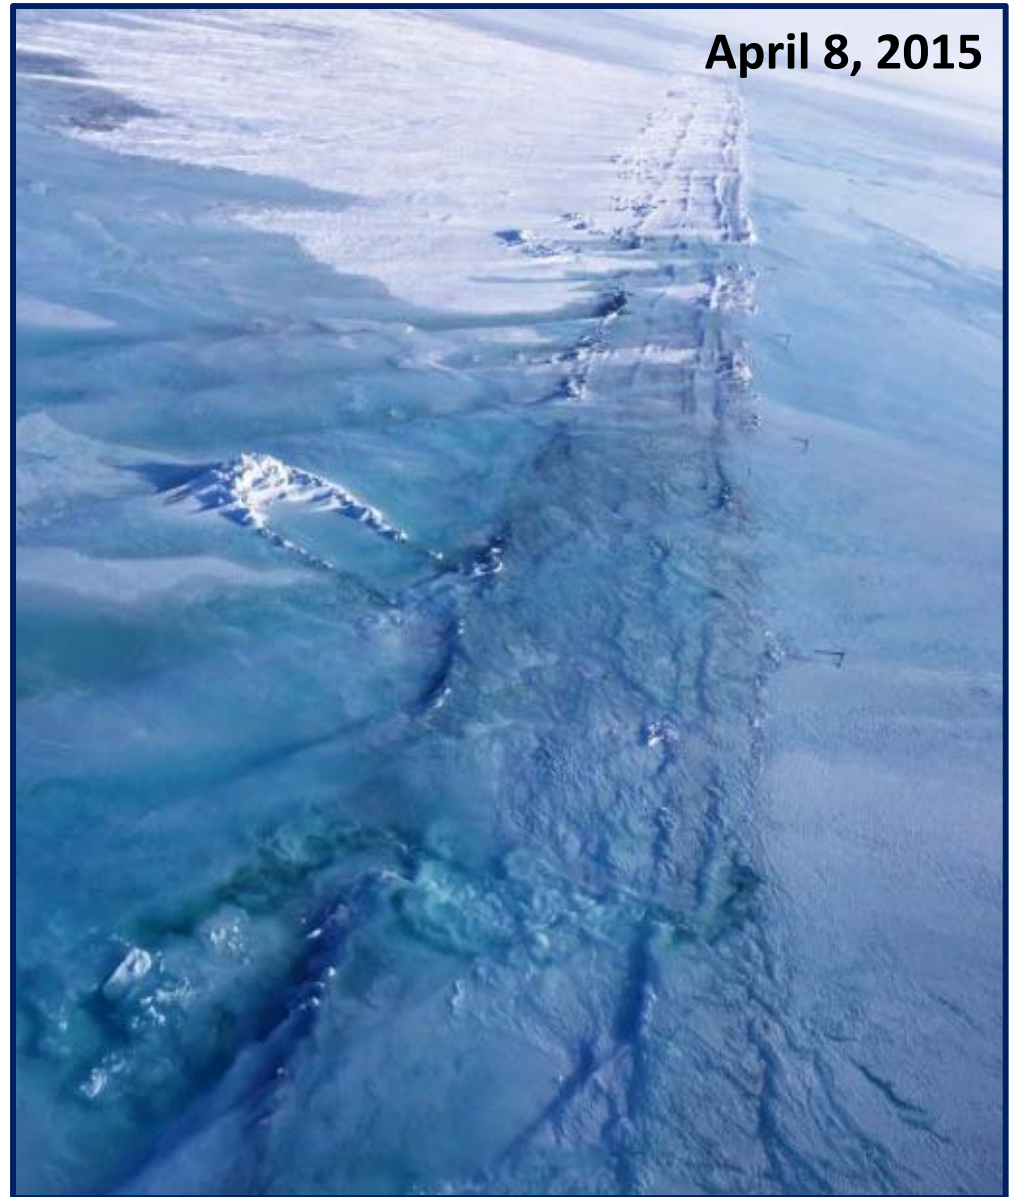
- **2015 Sag River icing developed in vicinity of Deadhorse and next to the Dalton Highway, the only road in northern Alaska that provides access to major Alaska oilfields and is parallel to the Trans-Alaska Oil Pipeline.**
- **The huge icing worked as an ice dam, which caused flooding of the highway and surrounding tundra and infrastructure.**
- **The overflow water raised to several meters above the normal winter level and flooded about 25 km of the Dalton Highway to a height of about one meter.**
- **This event led to the closure of the Dalton Highway from March 30 to April 2 and from April 5 to April 12.**

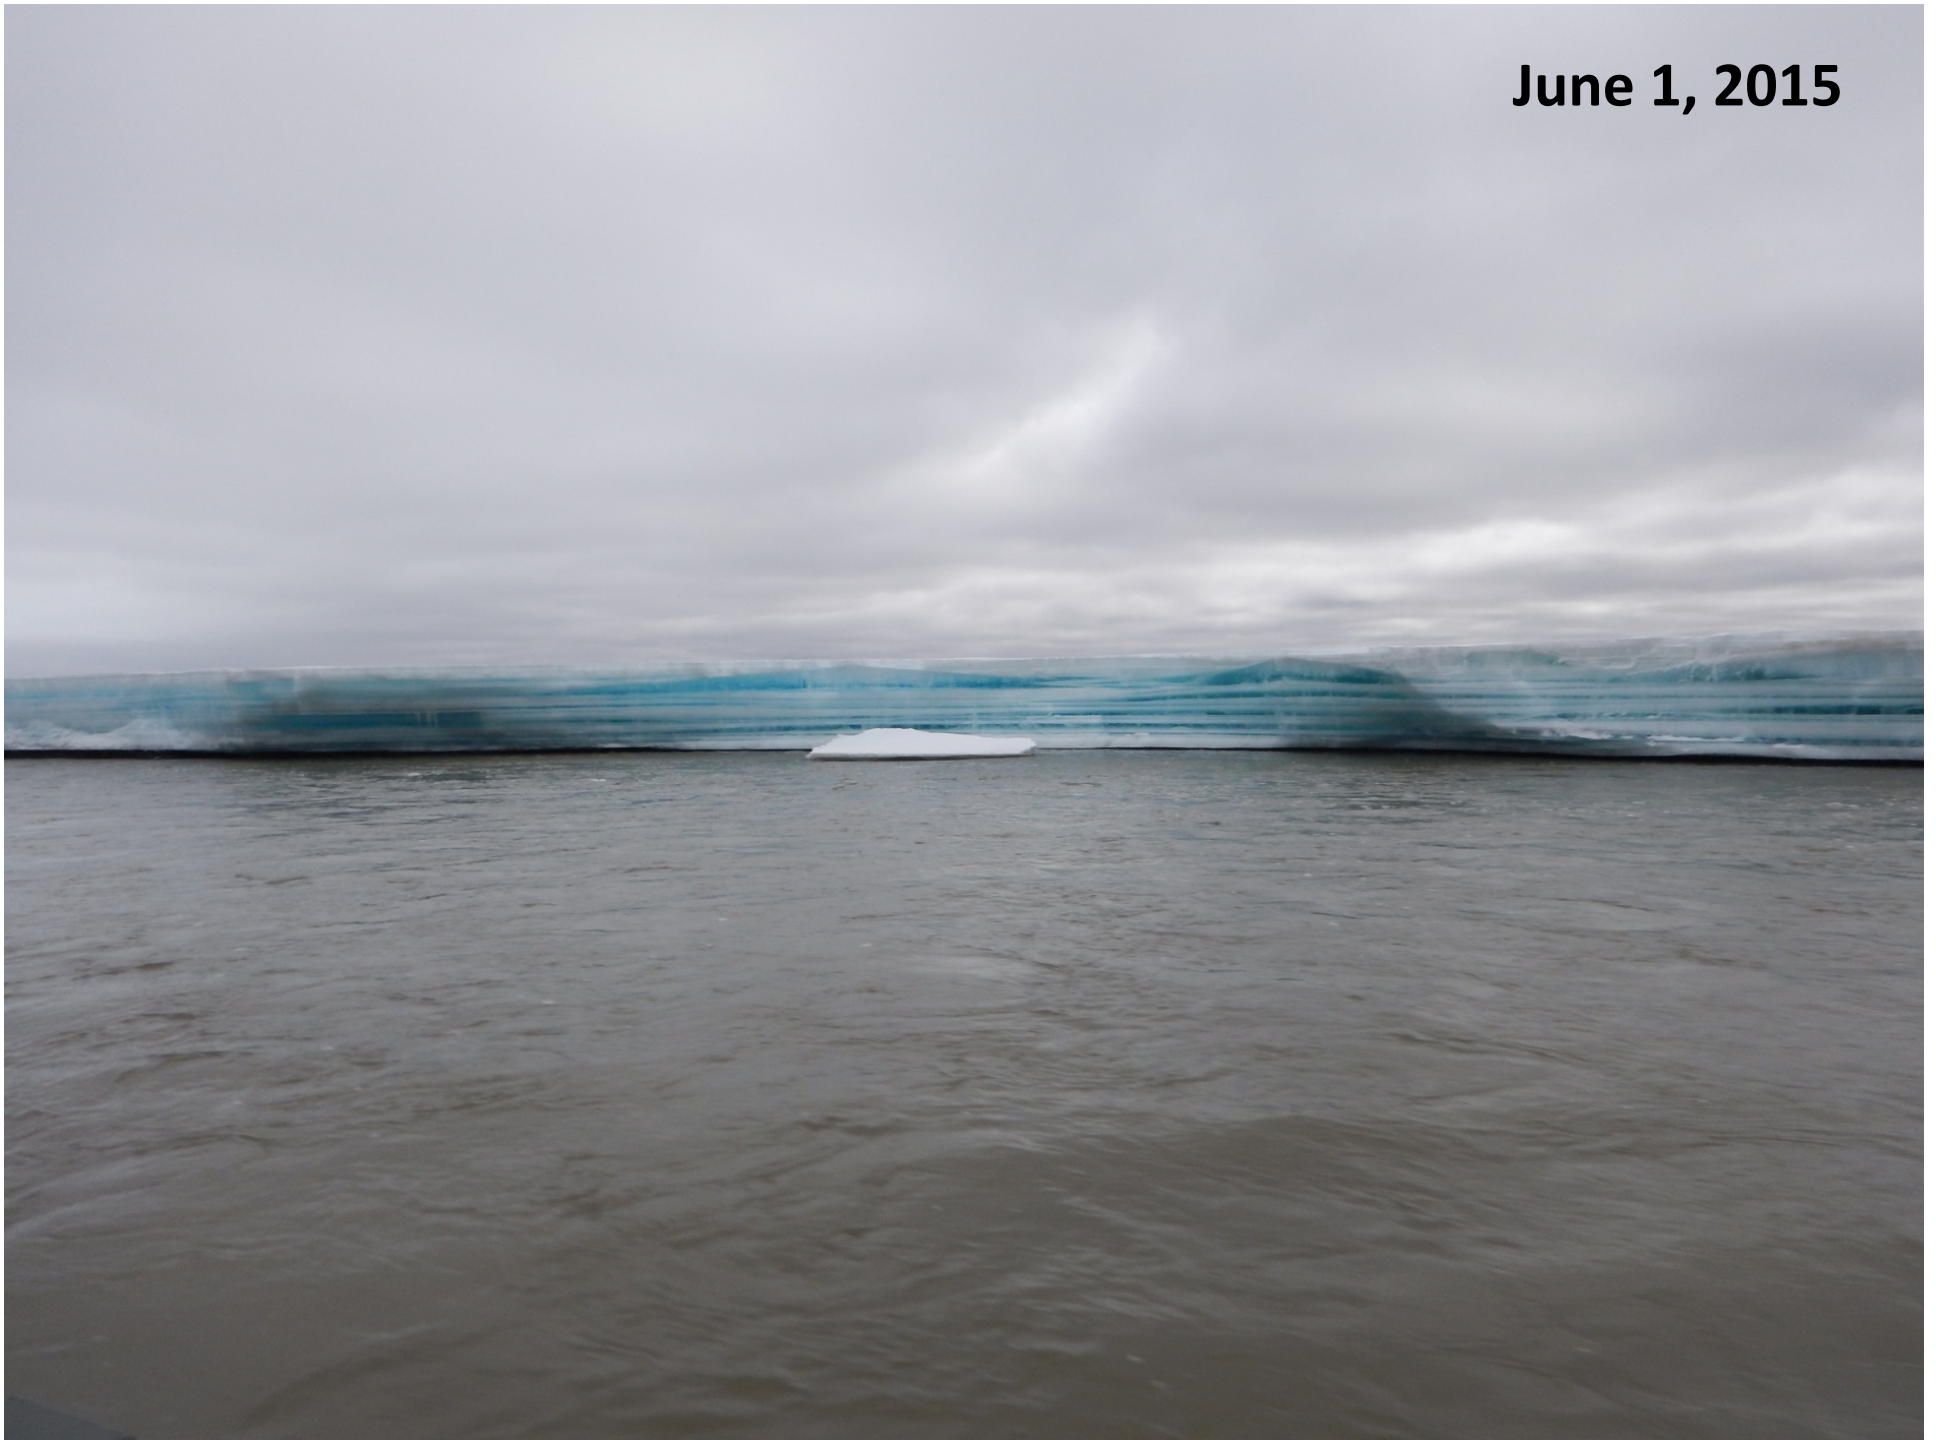
June 1, 2015

Flooding of the Dalton Highway and Deadhorse Airport.

- In mid-May, higher than usual air temperature in the upper watershed caused fast melting of snow and high floodwater, which was obstructed in the Delta by the extensive ice dam.
- The floodwater ran over the highway, washed out several stretches of it, and reached the Deadhorse Airport. The highway was closed again and reopened on June 5, after a 18-day-long closure.
- Media in Alaska, nationwide and even abroad covered the Dalton Highway flooding and some of them characterized it as “epic” and the flooding of biblical proportion.
- The Alaska governor Bill Walker twice (in April and May) issued Declarations of Disaster Emergency due to the unprecedented flooding.
- Cost of the highway repair: \$46 M.

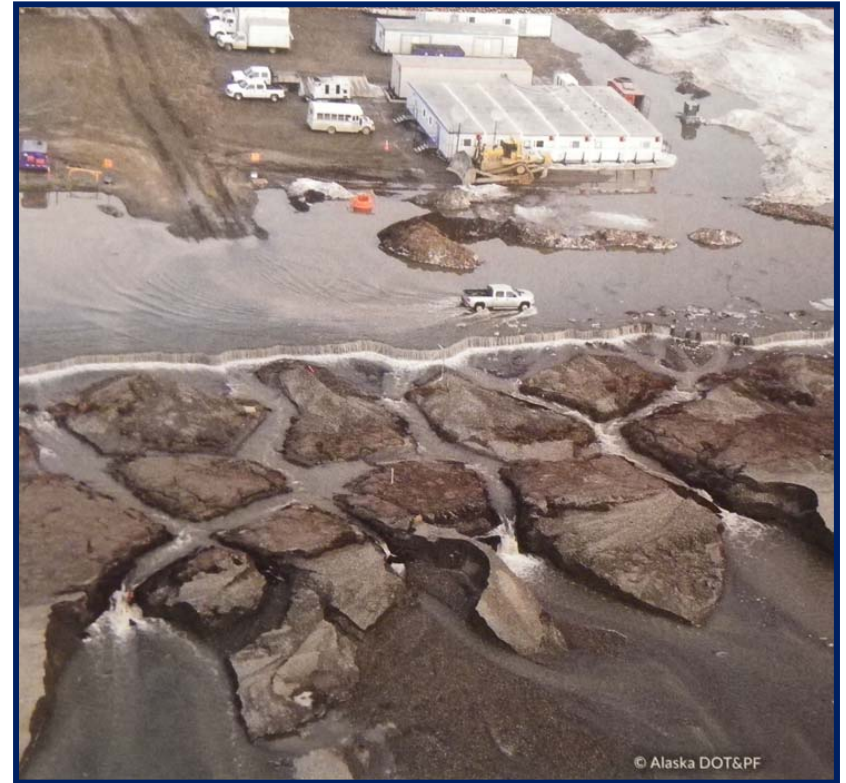
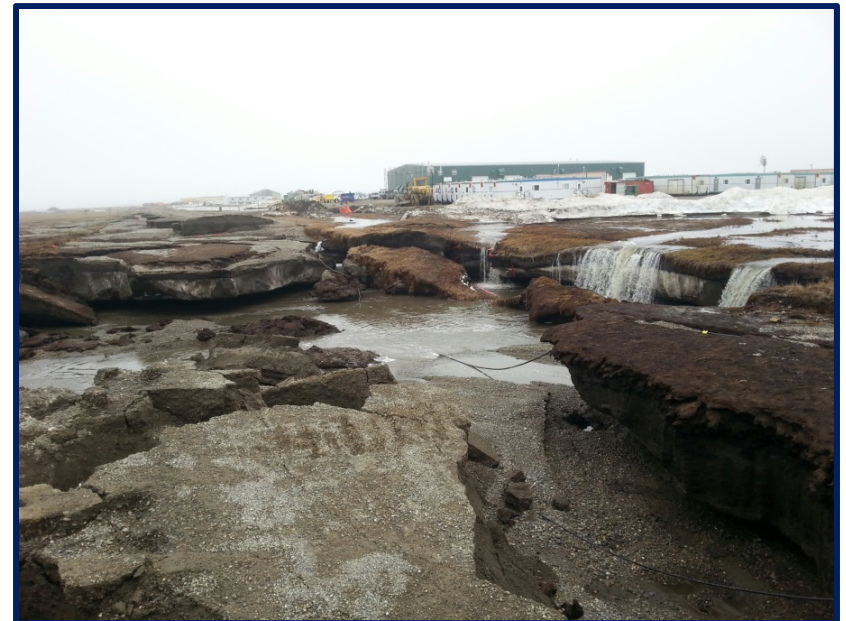
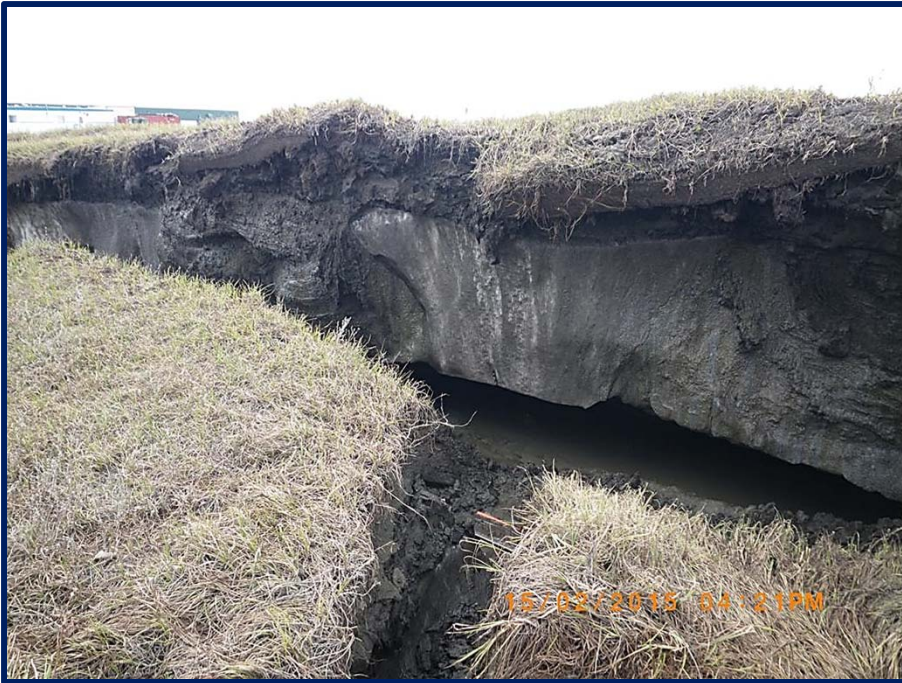
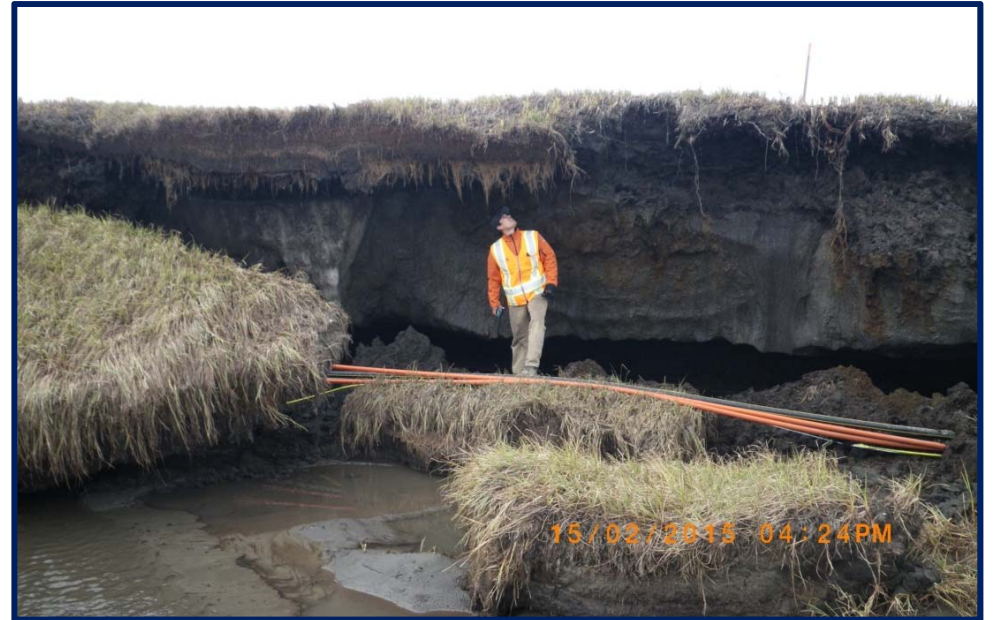
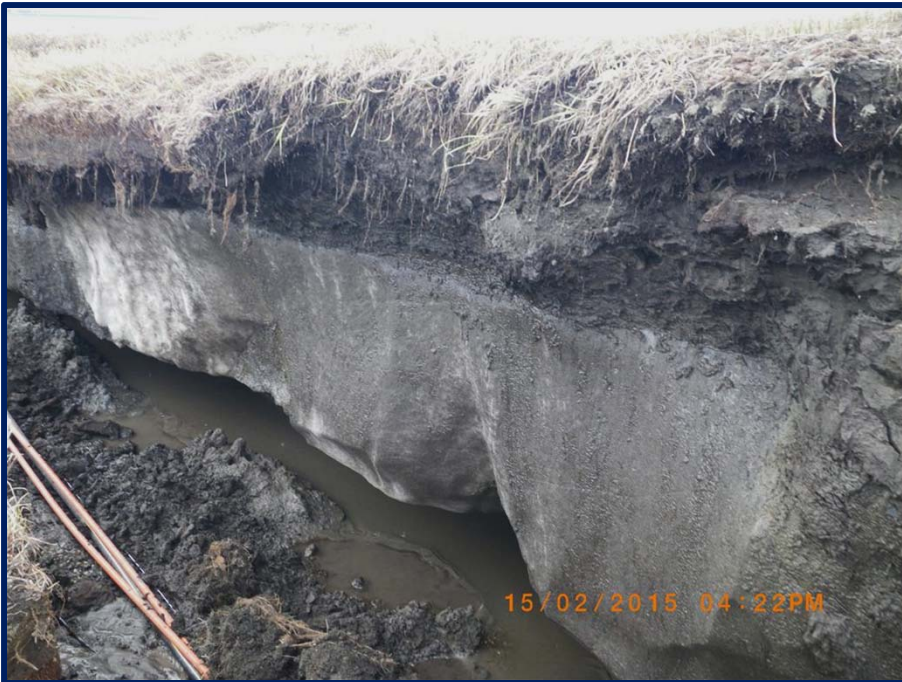
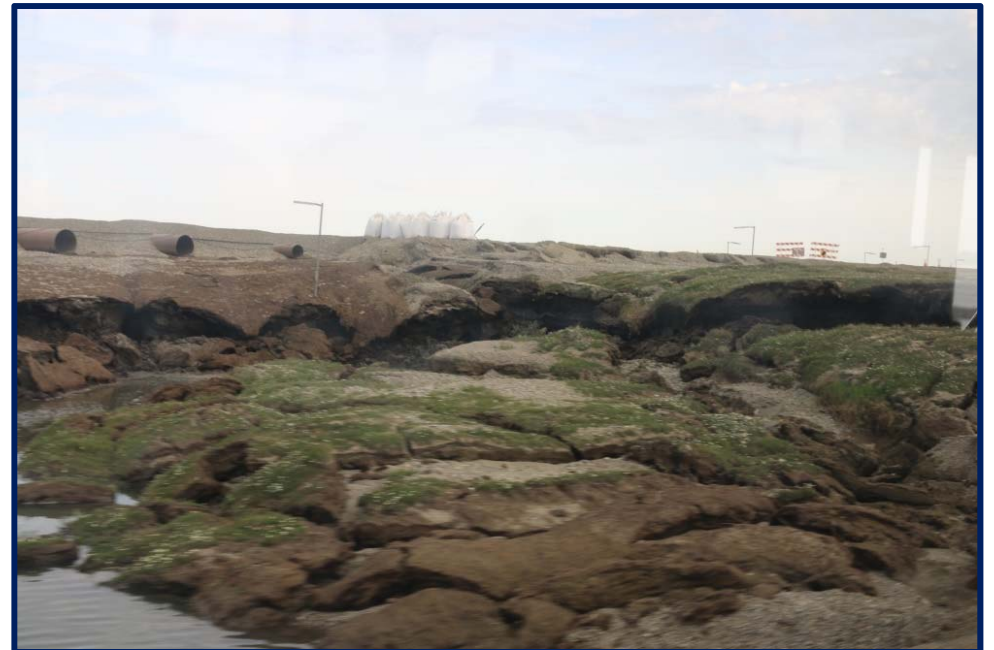
- In May 2015, flooding overflowed the Dalton Highway and surrounding tundra. Running water was channelized by temporal culverts installed during the emergency response and by the troughs of high-centered polygons.
- Water ran into open thermal cracks and reached the gravel layer creating underground flow pathways through gravel toward the river. Running through the gravel, water eroded ice wedges and extremely ice-rich floodplain deposits from below and from the sides, which caused significant settlement of the polygonal surface.
- The organic-rich active layer strengthened by roots of grasses and shrubs was the most resistant to thermal erosion because . This thin resistant layer created the low residual polygonal ground that transformed from high-centered ice-wedge polygons.

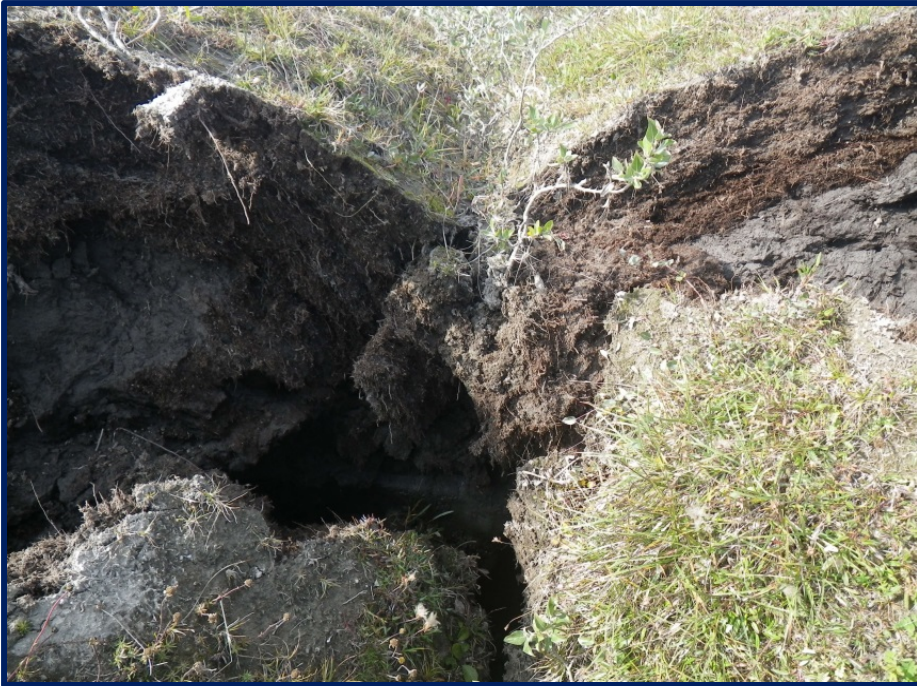
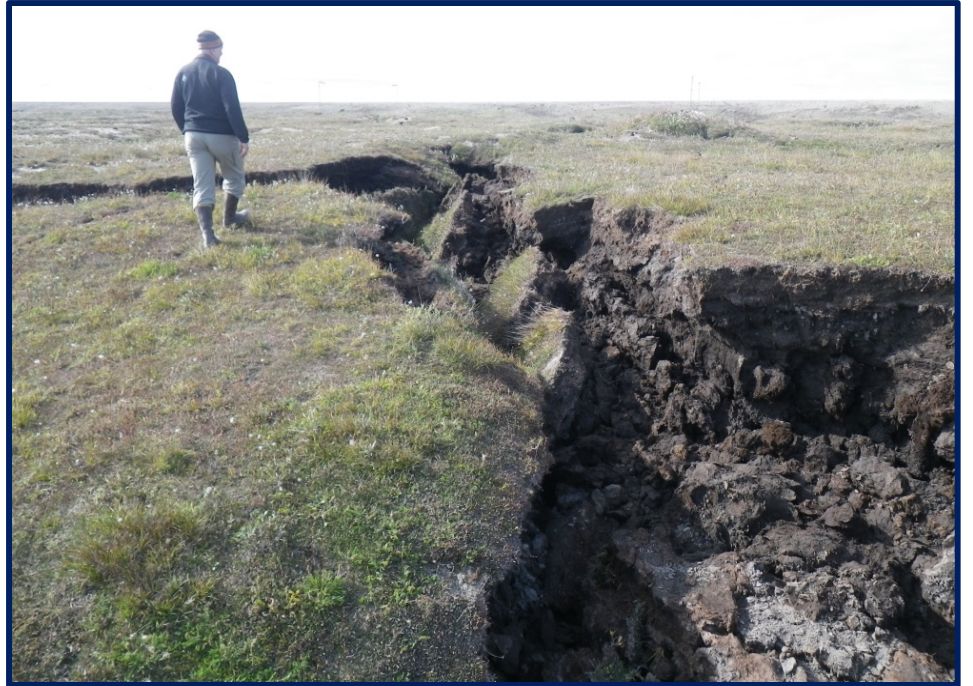
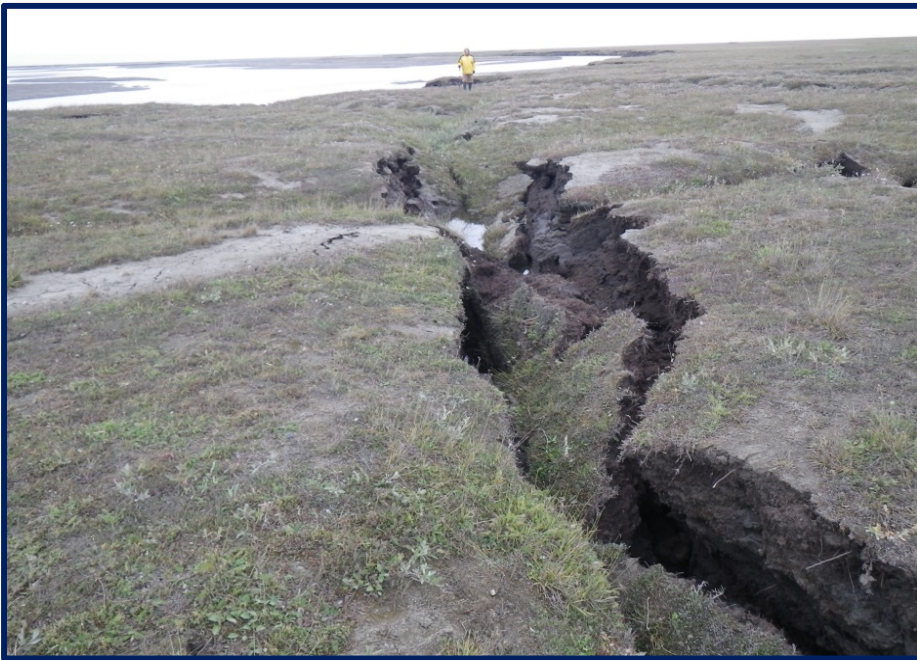
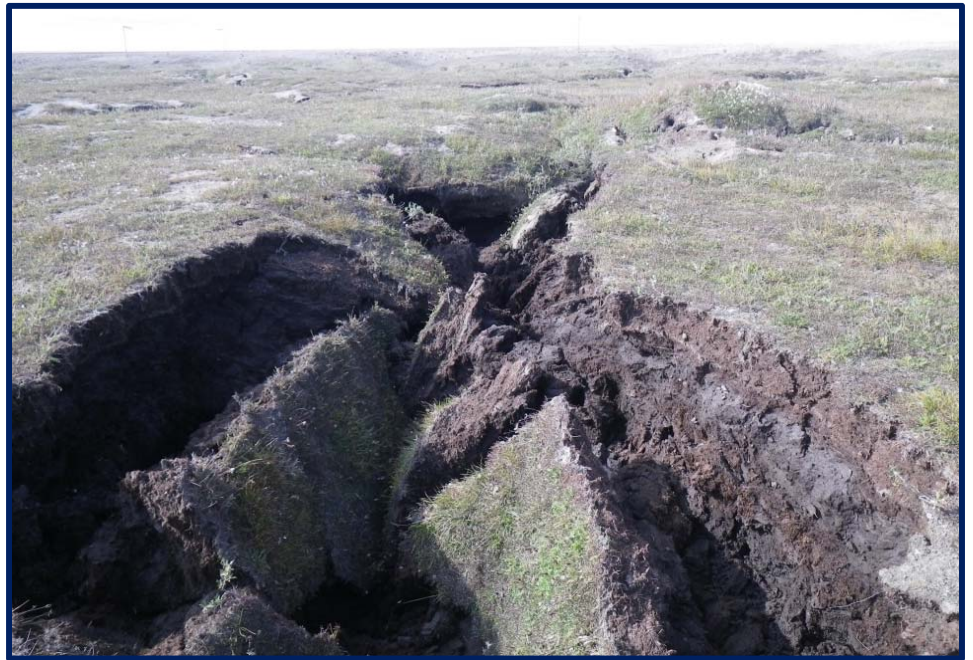
Site SR-1, August 2015, after the flooding. Troughs concentrate flow and water creates funnels

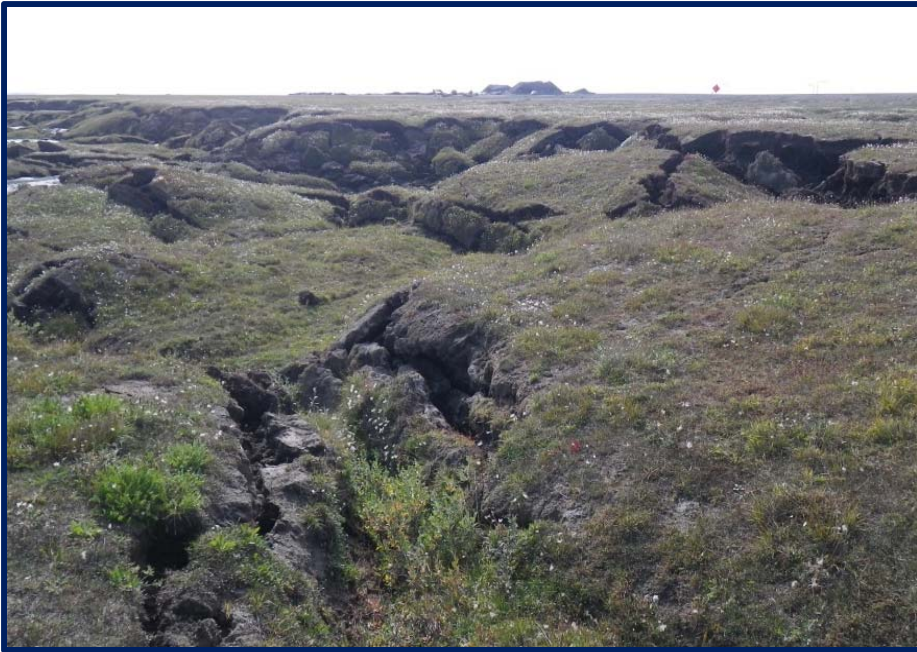
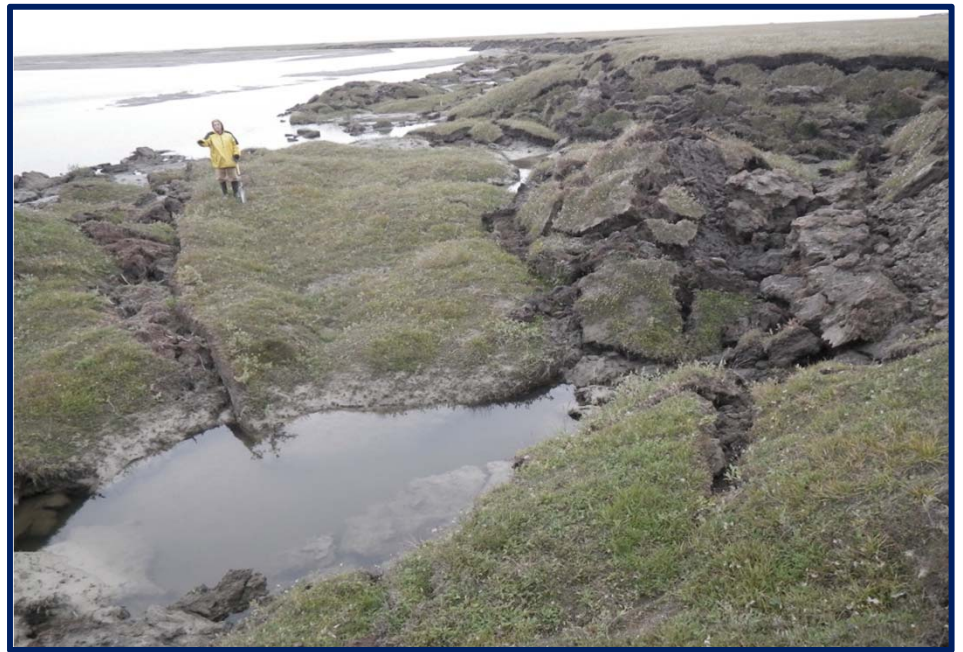
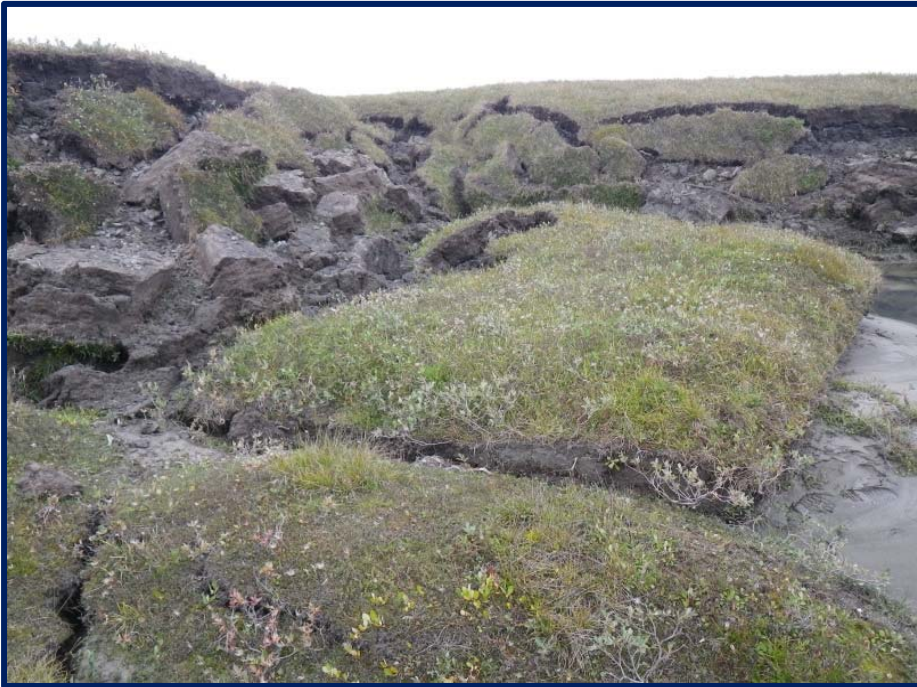
Site SR-1 after the flooding and underground erosion, August 2015.

- Formation of the gigantic icing and following “epic” flooding of the Sag River Delta, Alaska in spring 2015 were most likely caused by human activity.
- A vast area of high-centered polygons was degraded by flooding water reaching the gravel layer through open cracks and melting ground ice and thawing ice-rich flood-plain deposit from below.

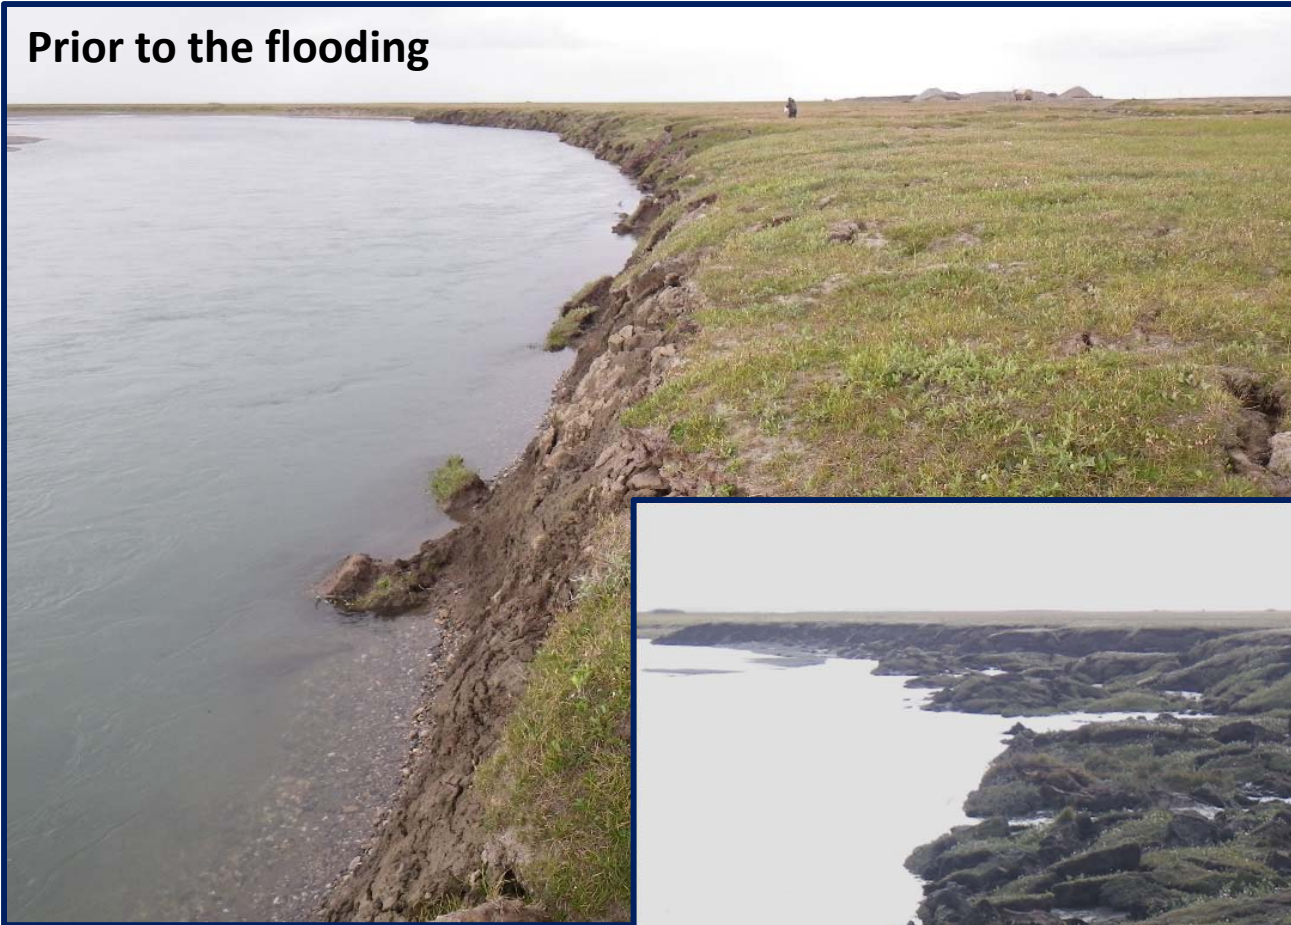
Study site SR-1

Prior to the flooding
