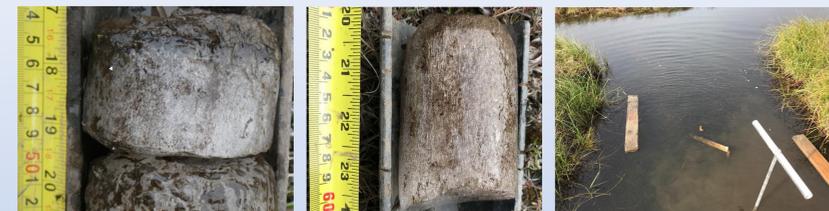
Figure 5. Ice-wedge degradation at T1-100T-1 site (CS, Transect T1, see Figure 2A for location). On August 7, 2014, ice wedge was protected by a very thin layer of frozen soil (PL1 = 1 cm) (Left), and on August 18, 2020, this wedge was degrading (PL2 = 0 cm) (Center). Total depth to wedge ice from the soil surface had increased from 45 cm in 2014 to 50 cm in 2020, and a shallow dry trough that was observed in 2014 had transformed by 2020 into a deep trough above degrading ice wedge with water depth of 32 cm (Right).

Our studies at the PBO revealed significant changes in ice-wedge status that had occurred from 2011-2015 to 2019-2022 at some of our coring sites. For example, T1-100T-1 site (CS) in 2014 had a shallow dry trough, and in 2019 at this site we could observe a deep water-filled trough, and this ice wedge was still degrading (Figure 5). On the contrary, significant stabilization had occurred at T1-10T-1 (Figure 6) and T5-26.7 (Figure 7) coring locations.

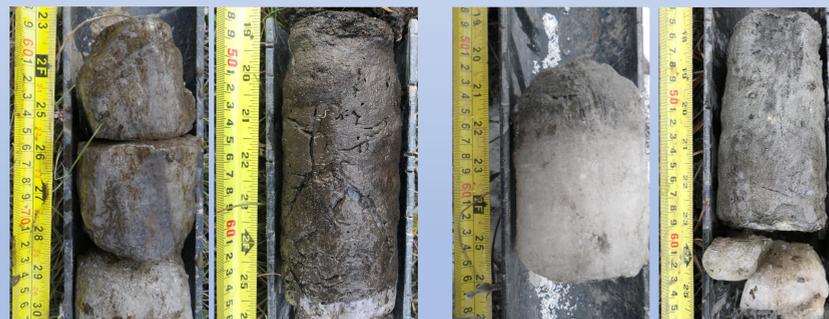
Figure 6. Ice-wedge stabilization at T1-10T-1 site (CS, Transect T1, see Figure 2A for location). Actively degrading wedge (PL1=0 cm), August 6, 2014 (Left) had stabilized (PL2=15 cm) by August 18, 2020 (Right). Total depth to wedge ice from the soil surface had increased from 58 cm in 2014 to 63 cm in 2020.
