ALASKA GEOBOTANY
CENTER DATA REPORT

ROAD EFFECTS AT AIRPORT STUDY SITE, PRUDHOE BAY, ALASKA, SUMMER 2015

AGC 16-01

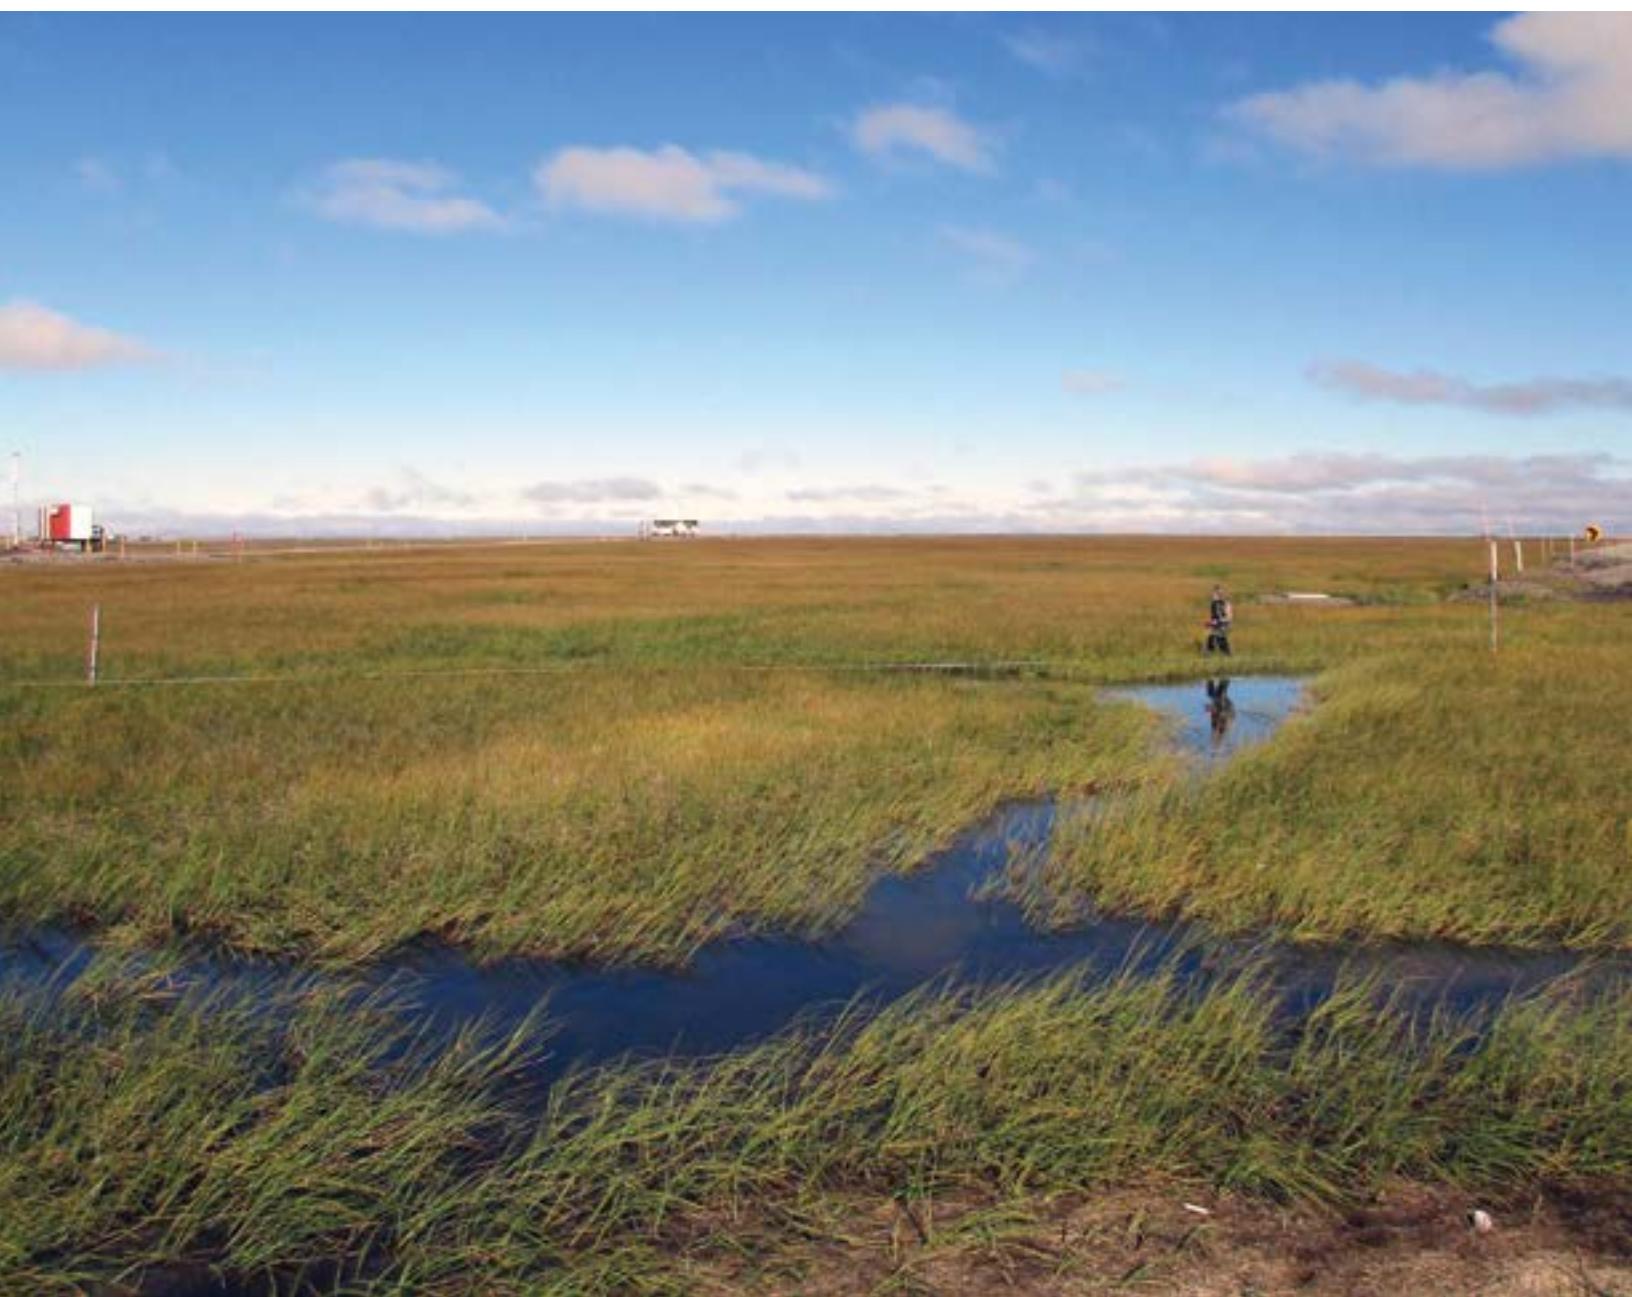
Vegetation survey along Transect 4. High-centered polygons with thermokarst and flooded ice-wedge-polygon troughs that have developed in a flooded area between the Dalton Highway on the right and the Deadhorse Airport runway on the left. Photo: IMG_0013.

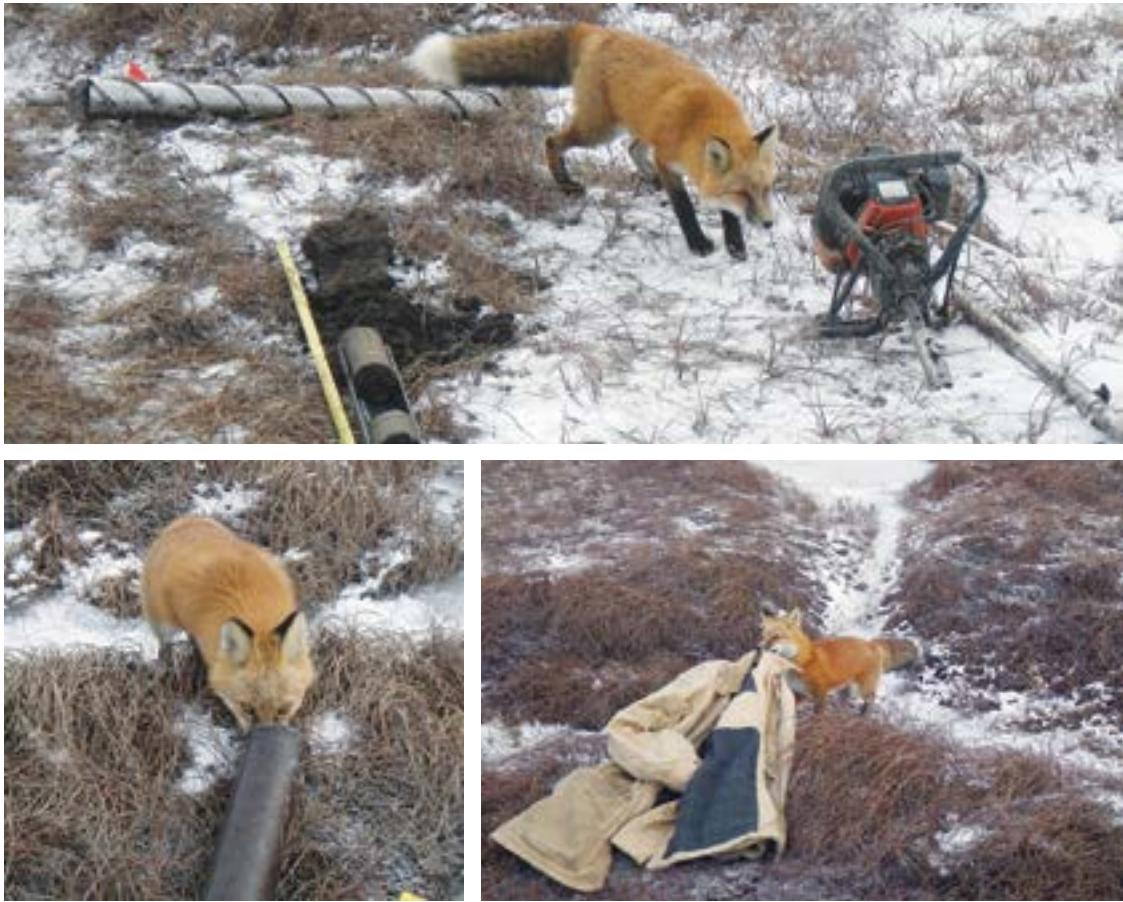
Field work, September 2015. Photos by Mikhail Kanevskiy: IMGP5057, IMGP5060, and IMGP5063.

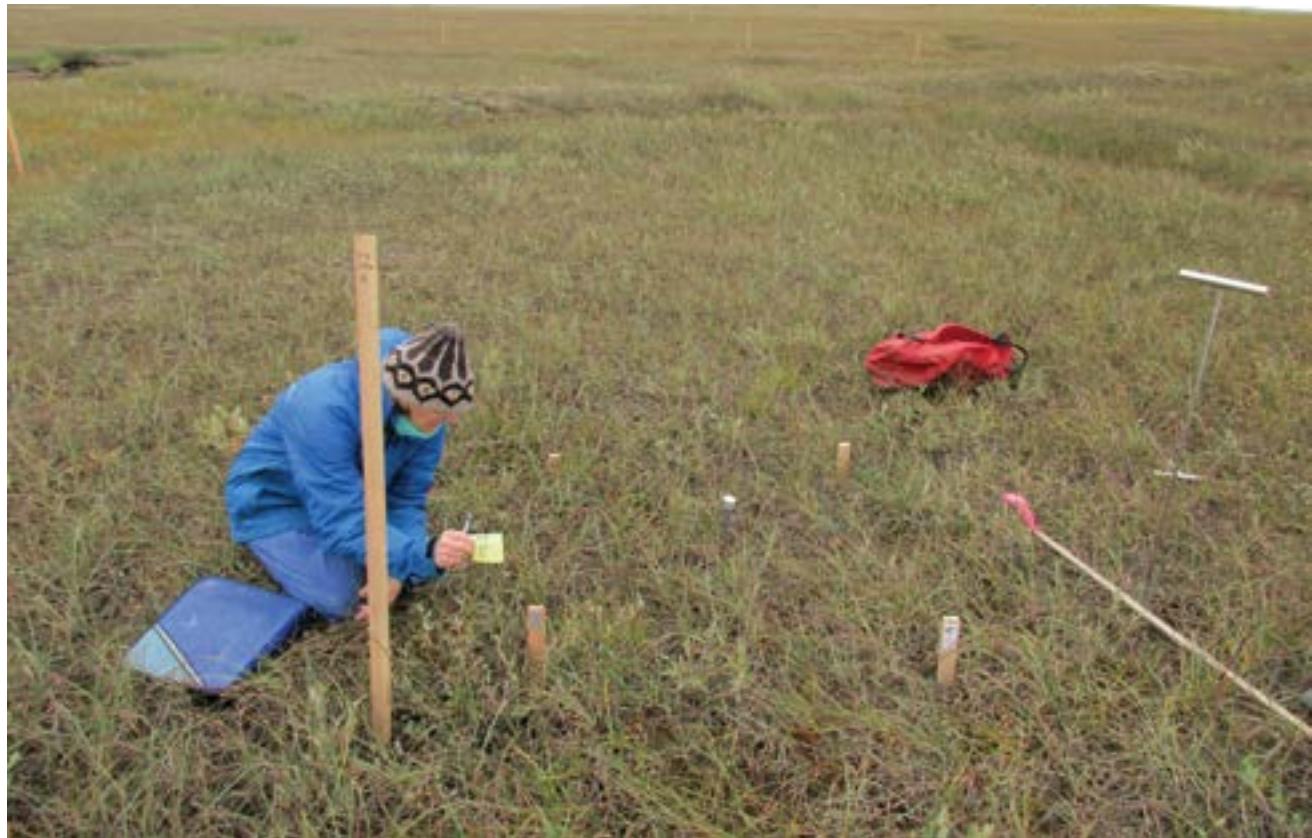
Figure 1.5. Plot T5-25-C located at 25 m from the start of Transect 5 in the center of a low-centered polygon. These wet low-centered polygons are likely similar to polygons that existed prior to construction of the road. Other plots along the transect are marked with stakes in the background. There is no flagged transect line as there is for Transects 1 to 4. *IMG_0298.jpg*.

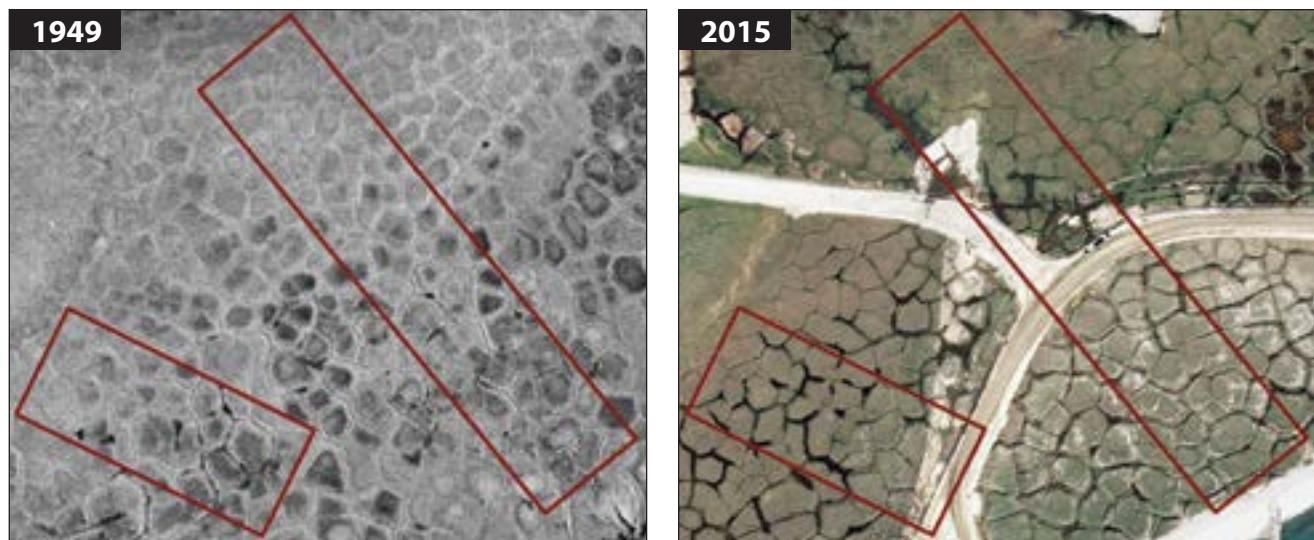
Figure 1.7. Close-ups of the Airport Site transects 3, 4 and 5 (detailed images in Fig. 1.2) from the 1949 and 2015 aerial photos (Fig. 1.6) show the conversion from low- to high-centered polygons to the southeast (right) side of the road, and the heavy disturbance and conversion to somewhat wetter conditions on the northwest (left) side of the road.

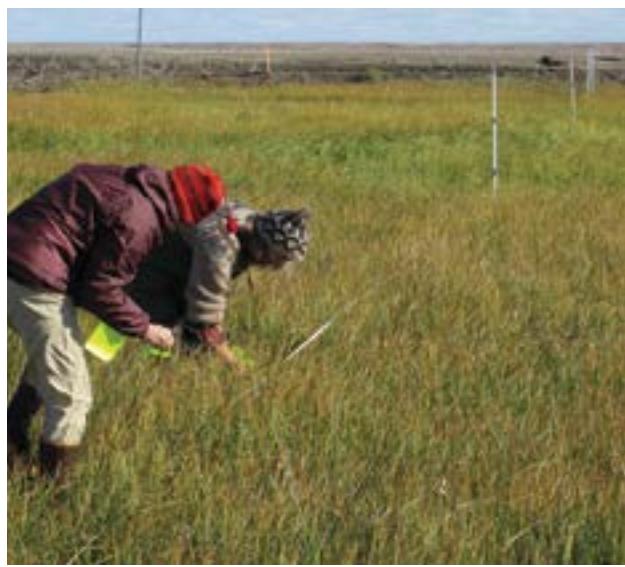
Figure 2.1. Placing yellow pin flags at 1 m intervals along Transect 3. Orange flags were placed every 5 m, and blue flags at 25 m intervals. Vertical poles were placed at 0, 5, 10, 25, 50 and 100 m from the road. Photo: IMG_0014.

We established three 100-m transects at the Airport Site to quantify differences in microtopography, soil temperatures, thaw depth, soils, vegetation, permafrost and snow in relationship to distance from the road. Transect 3 (T3) is on the southeast side of the Dalton Highway between the road and the Sagavanirktok River (Figs. 1.2a bottom and 1.3). Transects 4 and 5 (T4 and T5) are on the northwest side of the Dalton Highway. T4 is north of the airport runway access road (Figs. 1.2a top and 1.4); T5 is south of the access road (Figs. 1.2b and 1.5). Pin flags were placed at 1-m intervals along Transects 3 and 4, and vertical 150-cm PVC posts were placed at 0, 5, 10, 25, 50 and 100 m. The poles have blue stripes at 50, 100 and 150 cm height to help locate the transects in winter (Fig. 2.1).

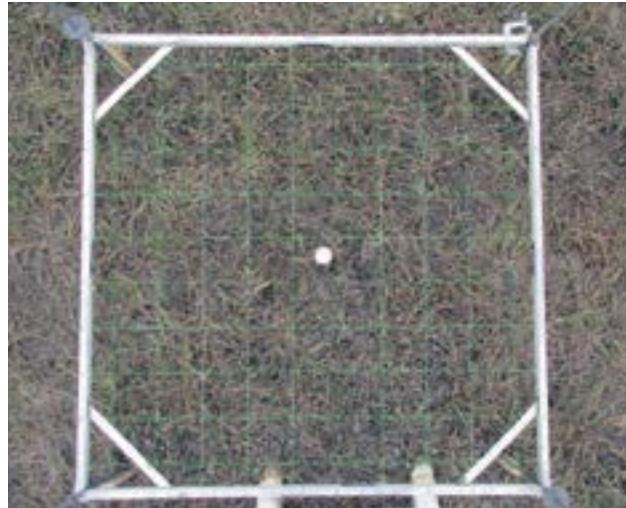
Figure 2.3. Plot T3 050 C (Transect 3, 50 m from road, polygon center) with point quadrat in place. The grid defines the 100 points for sampling. The point quadrat is mounted on legs that are inserted in metal washers nailed into the tundra to allow the frame to be repositioned at the same point for resampling. The central metal disk is the aluminum photo-point marker with the engraved plot number. The grid consists of two layers of monofilament fishing line. The plant species intercepted at each point is recorded. Grid points in the two layers of monofilament line are visually aligned at each point to avoid problems of parallax in accurately locating each point in the plant canopy. Photo: IMG_0059.jpg.

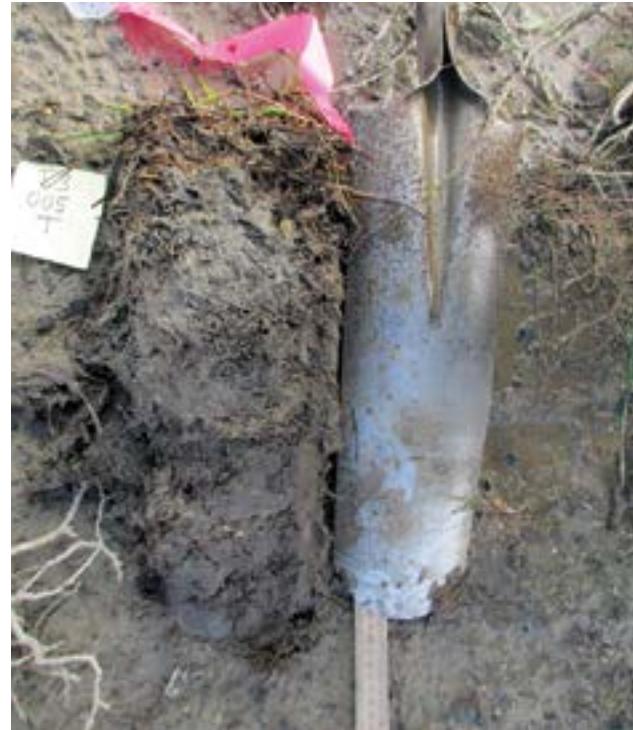
Figure 2.4. Soil plug from trough of an ice-wedge polygon 5 m from the road on Transect 3. The back of the Sharpshooter shovel used to extract the soil plugs is shown. Note the gray color at the top of the organic soil horizon underlying the surface layer of moss, indicating leaching of dust into the organic layer. Photo: IMG_216.

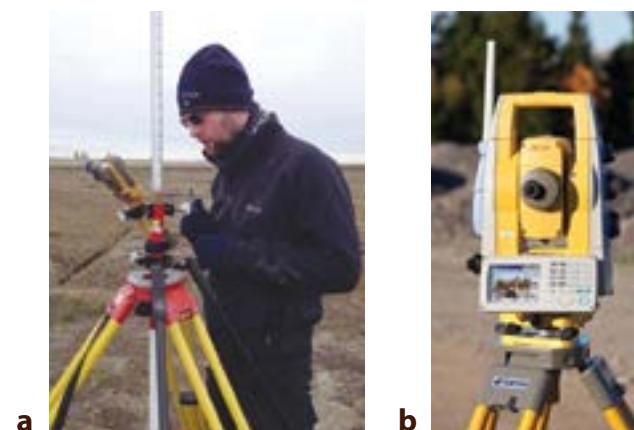
Figure 2.5. (a) Marcel Buchhorn surveying plot markers using a Topcon RTK GPS HyPer Lite + GPS system. **(b)** Topcon IS-3 Imaging Station and Laser Scanner. Photo: Topcon.

measurements, we used a Topcon RTK HiPer Lite+GPS system in combination with a Topcon FC-2500 field controller (a handheld computer) for data acquisition (Fig. 2.5a).

For the creation of elevation profiles of Transects 3 and 4, we needed position data with a higher degree of accuracy, which we achieved using a Topcon IS-3 Imaging Station system in combination with an RC-4 advanced prism tracking and locking system, and the same FC-2500 field controller (Fig. 2.5b). This robotic, fully automatic, total imaging station and laser scanner allowed high-accuracy surveying at millimeter-levels (again with reference to the NGS benchmark point DF3643).

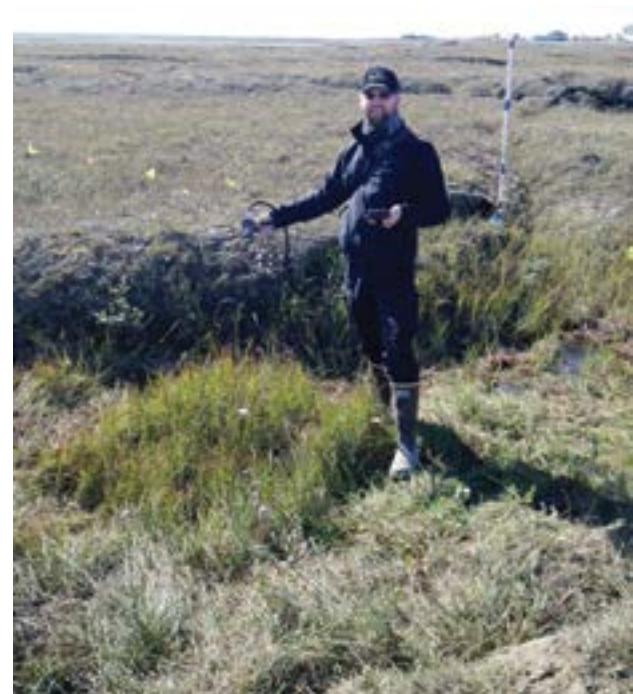
Figure 2.7. Marcel Buchhorn measures surface reflectance via field spectroscopy at a permanent vegetation plot in August 2015. Surface reflectance was measured at every 1 m flag and at each permanent plot on the 100-m transects T3 and T4 at the Airport Site.

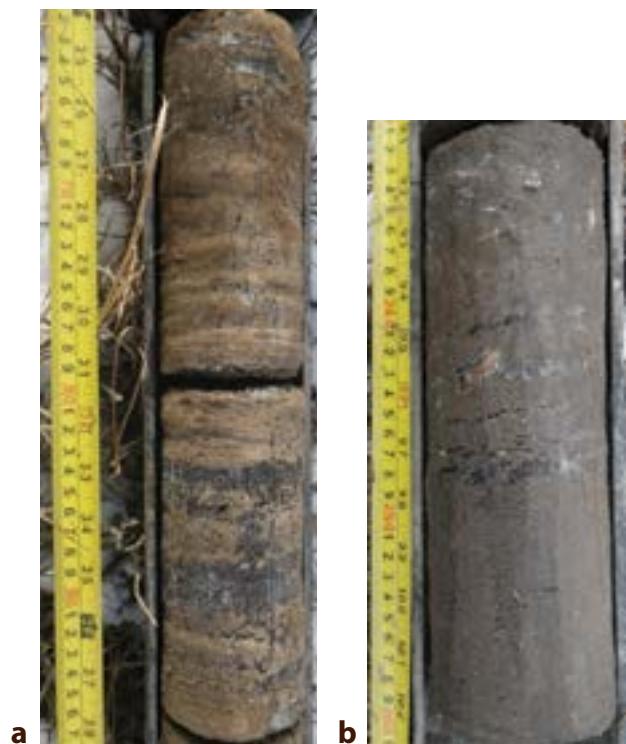
Figure 2.12. Frozen cores obtained from boreholes drilled in ice-wedge-polygon centers. (a) Borehole T3-59.0-C, ice-rich organic silt with peat inclusions, 62–97 cm. (b) Borehole T5-65.4-C, ice-rich organic silt, 233–257 cm.

Analysis of cryostructures showed that the thickness of the transient layer, which represents potential seasonal thawing under favorable conditions, was 1 cm at T3-59.0-C and 3 cm at T5-65.4-C. The upper permafrost in sections of these two boreholes was composed of organic-rich mineral soils of presumably eolian and lacustrine origin. Neither 2.5-m-deep borehole reached organic-poor mineral soils (silts, sands, or gravelly sands), which were encountered along Transects 1 and 2 at depths varying from 1.2 to 2.0 m. Gravimetric moisture content of soils was determined for these boreholes (Table 3.10). Photographs of the frozen soils are presented in Fig. 2.12.

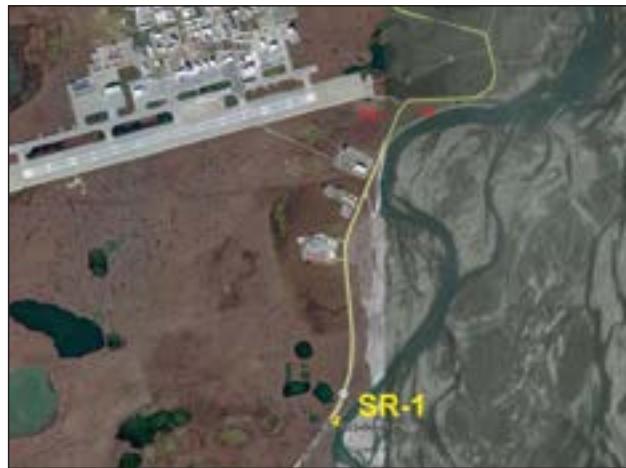
Figure 2.14. Location of Site SR-1 Image: Google Earth.

Site SR-1 is located on the left bank of the Sagavanirktok River approximately 2 km to the south of the Deadhorse airport ($70^{\circ}10'39.0''N$, $148^{\circ}26'12.1''W$) (Fig. 2.14). This area was strongly affected by thermal erosion during the catastrophic flooding in May-June of 2015 (Shur *et al.*, 2016), which has completely changed the landscape between the Dalton Highway and the Sagavanirktok riverbank (Fig. 2.17).

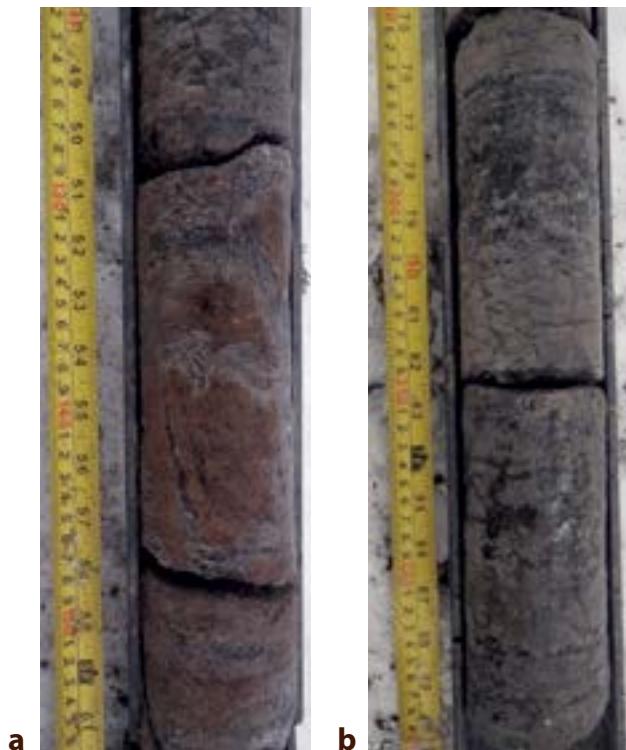
Figure 2.15. Frozen core obtained from borehole SR-1. (a) Ice-rich silt with peat inclusions, 123–154 cm. (b) Ice-rich organic-poor silt, 192–217 cm; ice-rich silty sand with coarse inclusions 217–226 cm.

5. Frozen silty sand with coarse inclusions (Fig. 2.15b), thickness: 9 cm (visible); total thickness unknown (we could not drill deeper than 2.26 m because of gravel)

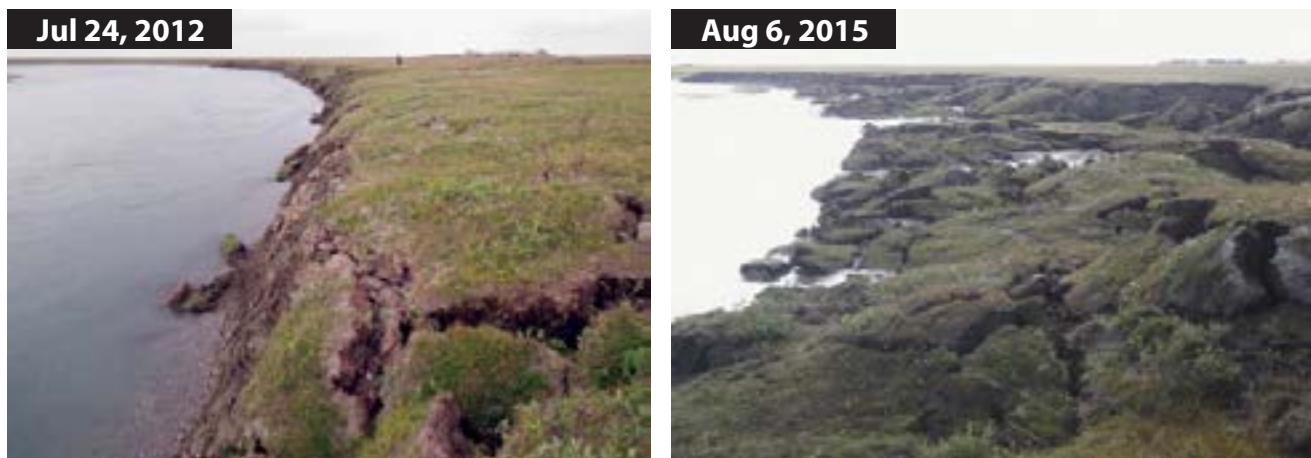
Figure 2.17. Left bank of the Sagavanirktoq River near Site SR-1 before and after the erosional event caused by catastrophic flooding in May-June of 2015.

Another coring site, Sagavanirktok River Site 1 (SR-1), was established south of the Airport Site along the Sagavanirktok River (Figs. 2.14 and 2.19), where local destruction of the highway caused by flooding from the Sagavanirktok River in spring 2015 created a major disturbance (Figs. 1.8 and 2.17) (Shur *et al.*, 2016).

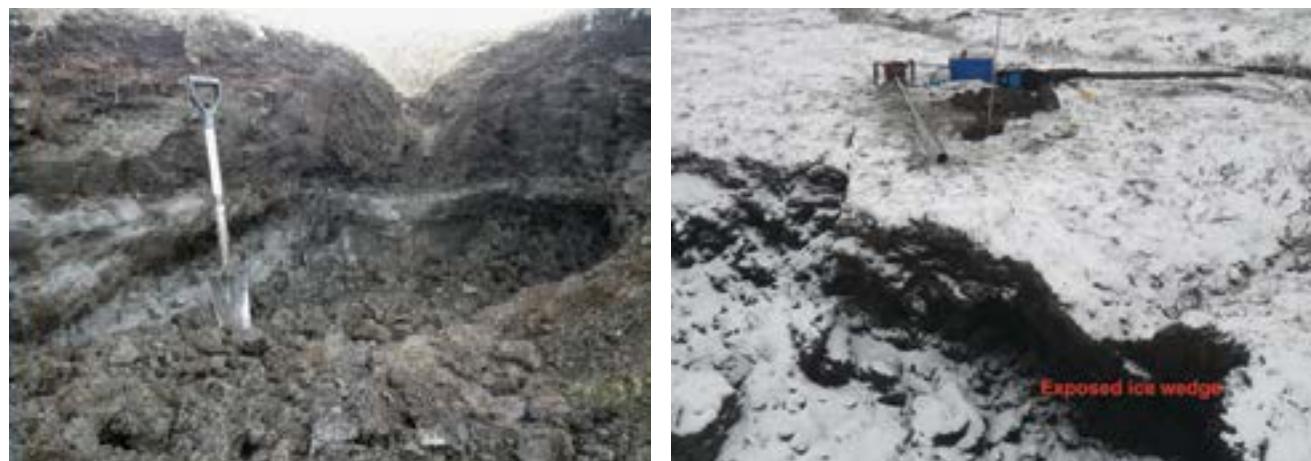
Figure 2.18. Ice wedge exposed at Site SR-1, August 8, 2015. This exposure is also shown in the drawing in Fig. 2.20.

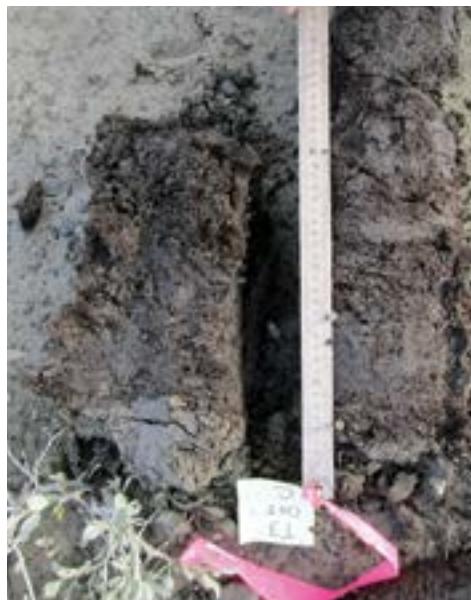
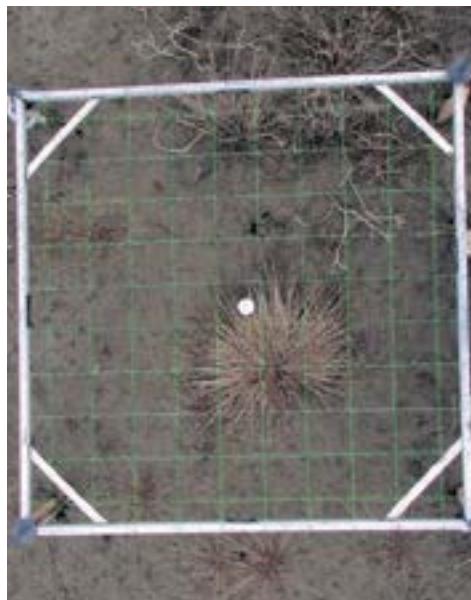
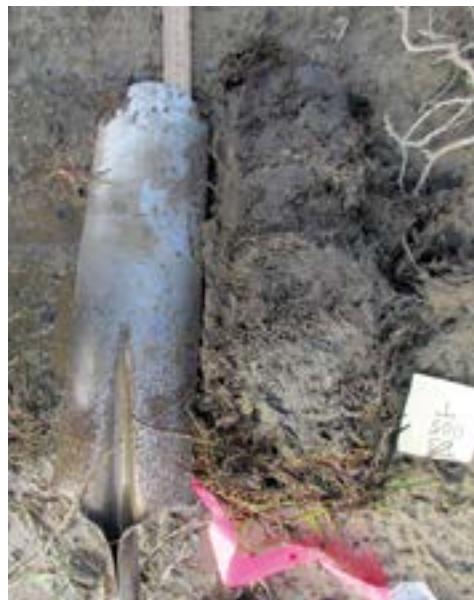
Transect 3, 5 m, polygon center (T3-005-C). (l-r) site location with 1-m plot marked with wooden corner stakes, plot with 1-m grid, soil plug.

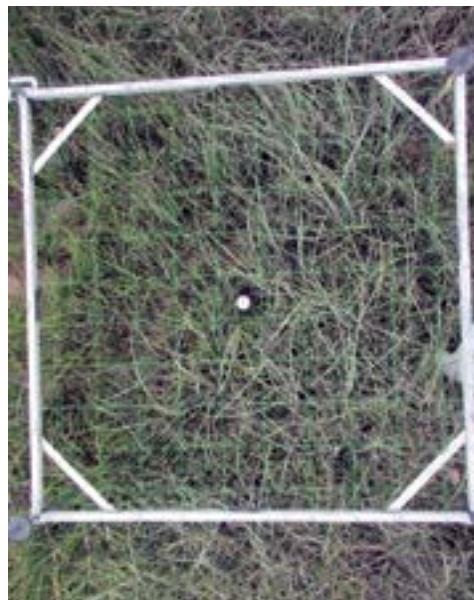
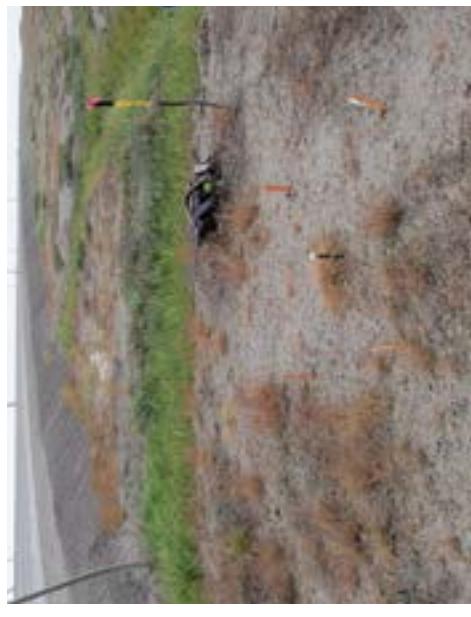
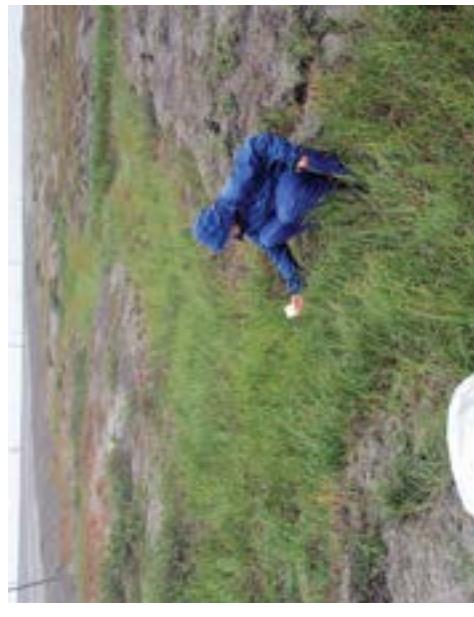
Transect 3, 5 m, polygon trough (T3-005-T). (l-r) site location with 1-m plot marked with wooden corner stakes, plot with 1-m grid, soil plug.

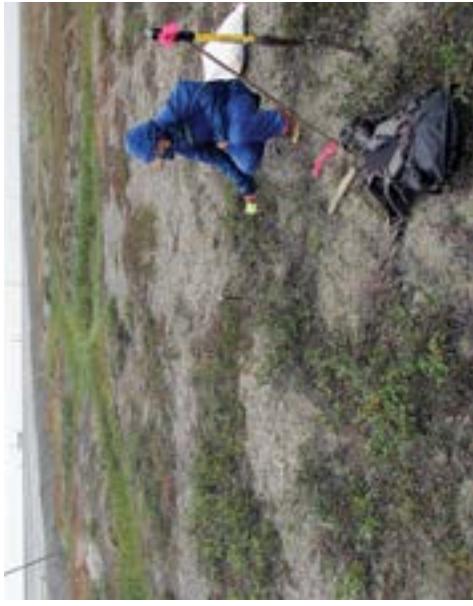
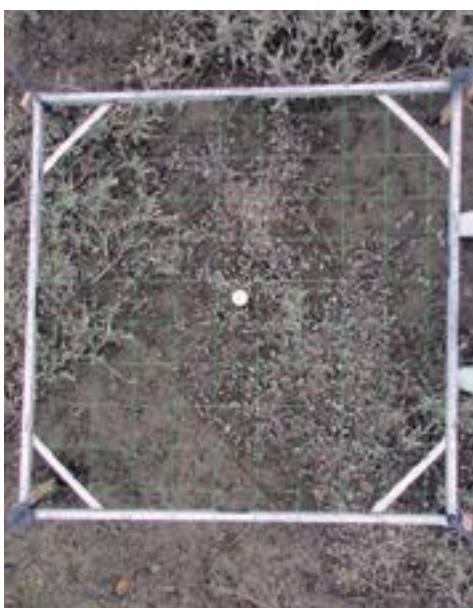
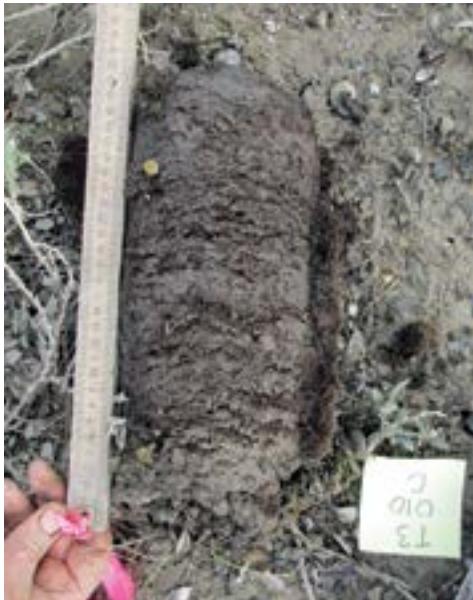
Transect 3, 10 m, polygon center (T3-010-C). (l-r) site location with 1-m plot marked with wooden corner stakes, plot with 1-m grid, soil plug.

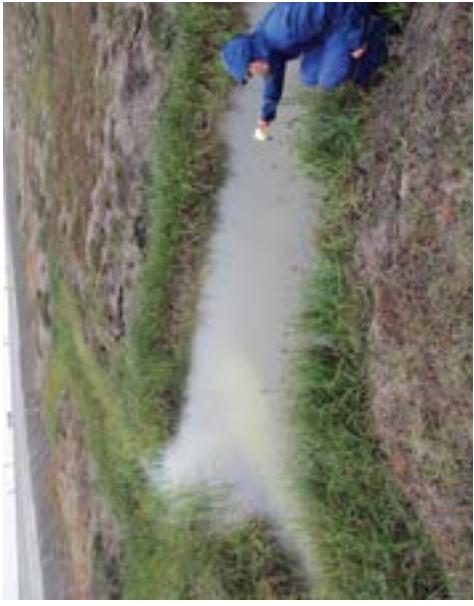
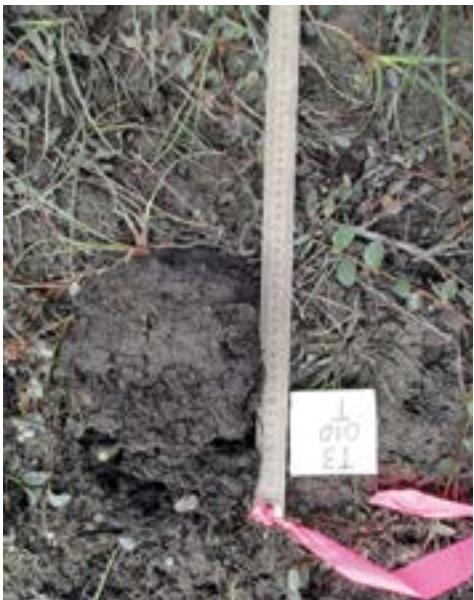
Transect 3, 10 m, polygon trough (T3-010-T). (l-r) site location with 1-m plot marked with wooden corner stakes, plot with 1-m grid, soil plug.

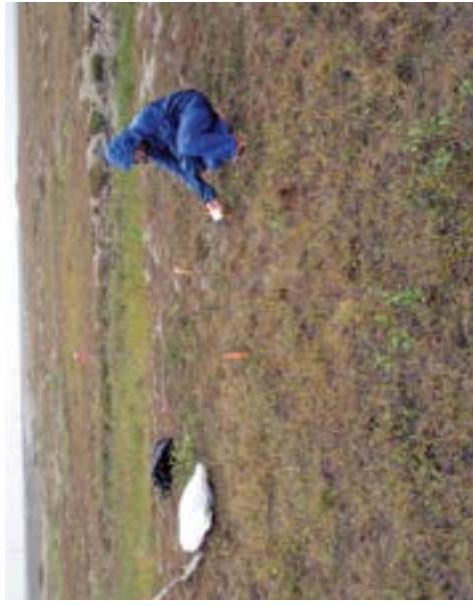
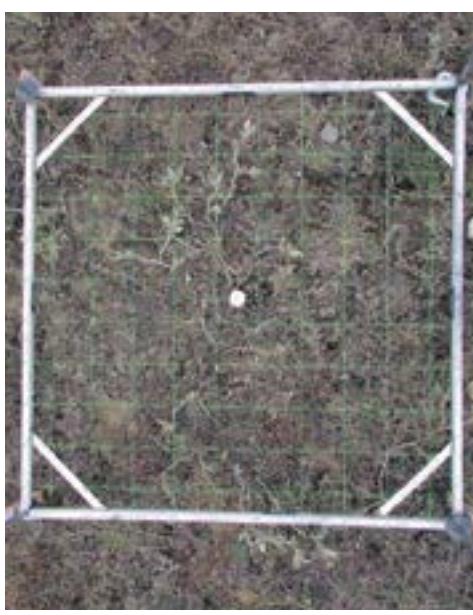
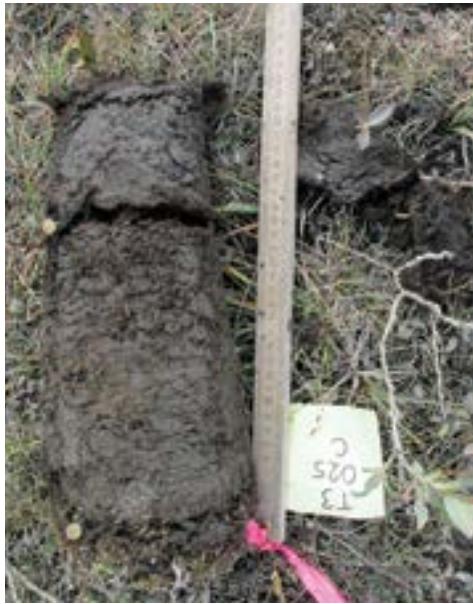
Transect 3, 25 m, polygon center (T3-025-C). (l-r) site location with 1-m plot marked with wooden corner stakes, plot with 1-m grid, soil plug.

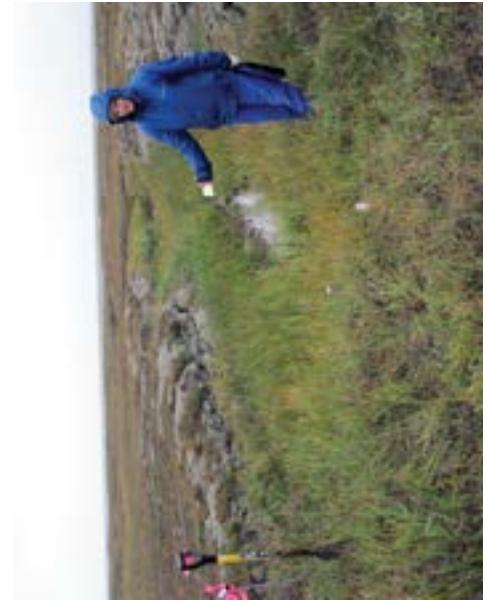
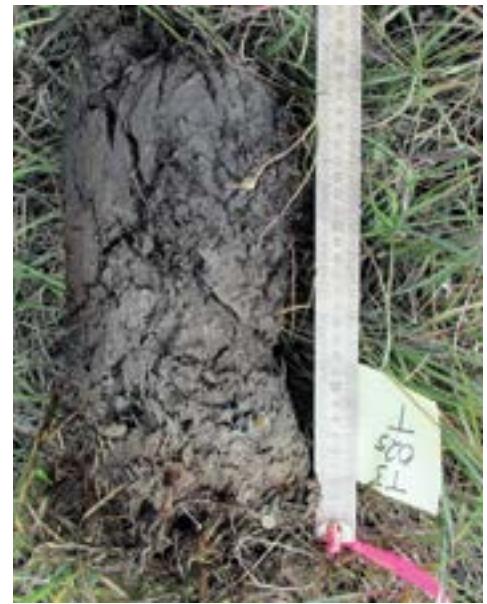
Transect 3, 25 m, polygon trough (T3-025-T). (l-r) site location with 1-m plot marked with wooden corner stakes, plot with 1-m grid, soil plug.

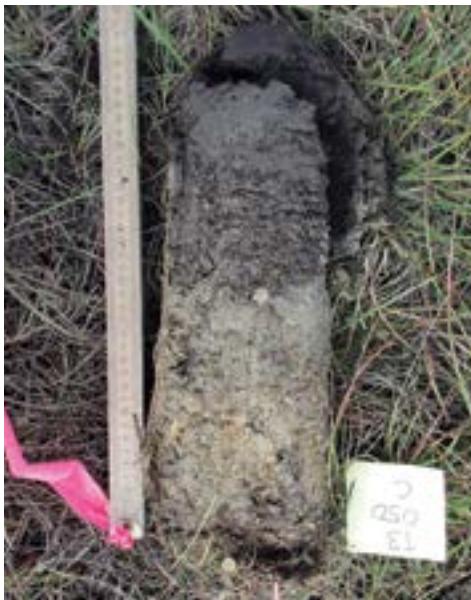
Transect 3, 50 m, polygon center (T3-050-C). (l-r) site location with 1-m plot marked with wooden corner stakes, plot with 1-m grid, soil plug.

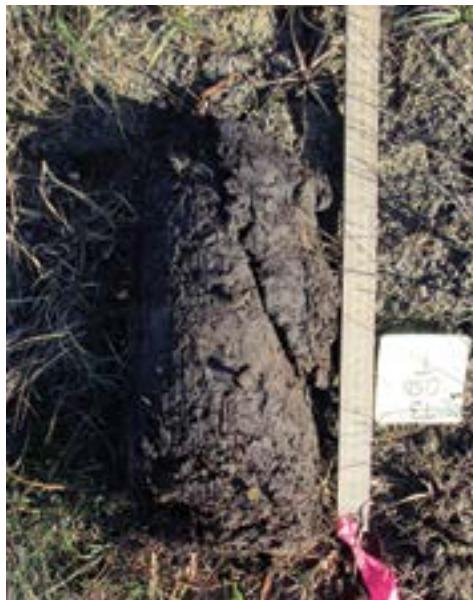
Transect 3, 50 m, polygon center (T3-050-T). (l-r) site location with 1-m plot marked with wooden corner stakes, plot with 1-m grid, soil plug.

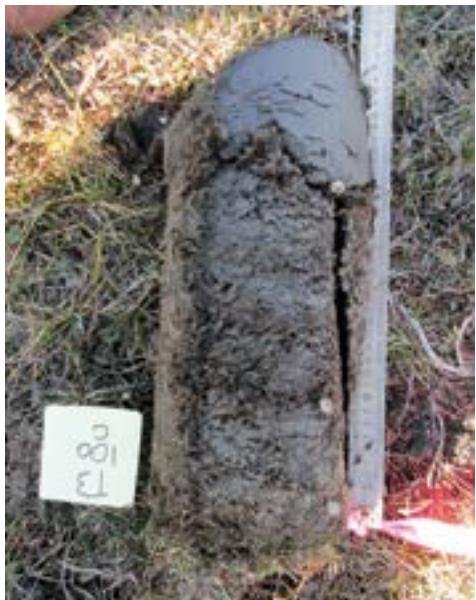
Transect 3, 100 m, polygon center (T3-100-C). (l-r) site location with 1-m plot marked with wooden corner stakes, plot with 1-m grid, soil plug.

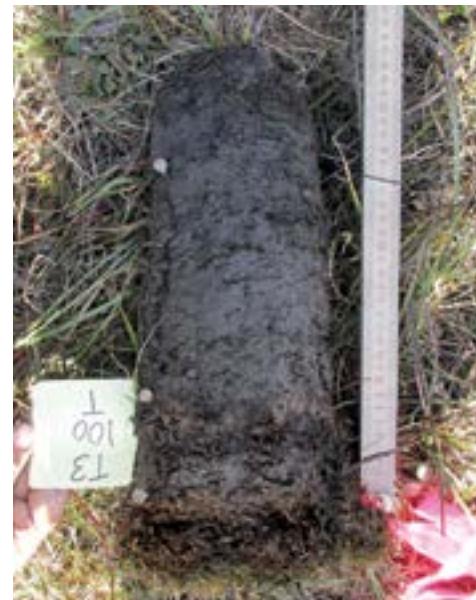
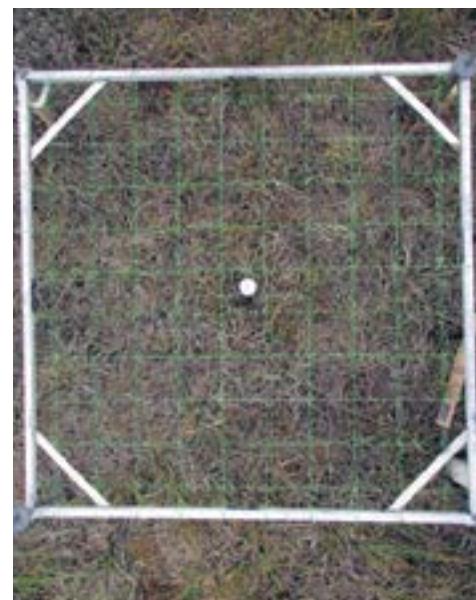
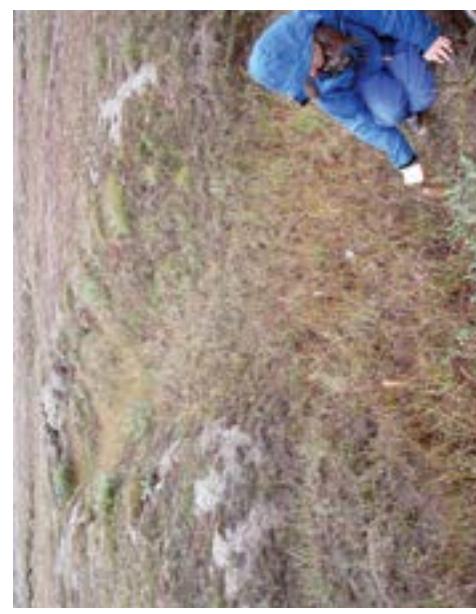
Transect 3, 100 m, polygon trough (T3-100-T). (l-r) site location with 1-m plot marked with wooden corner stakes, plot with 1-m grid, soil plug.

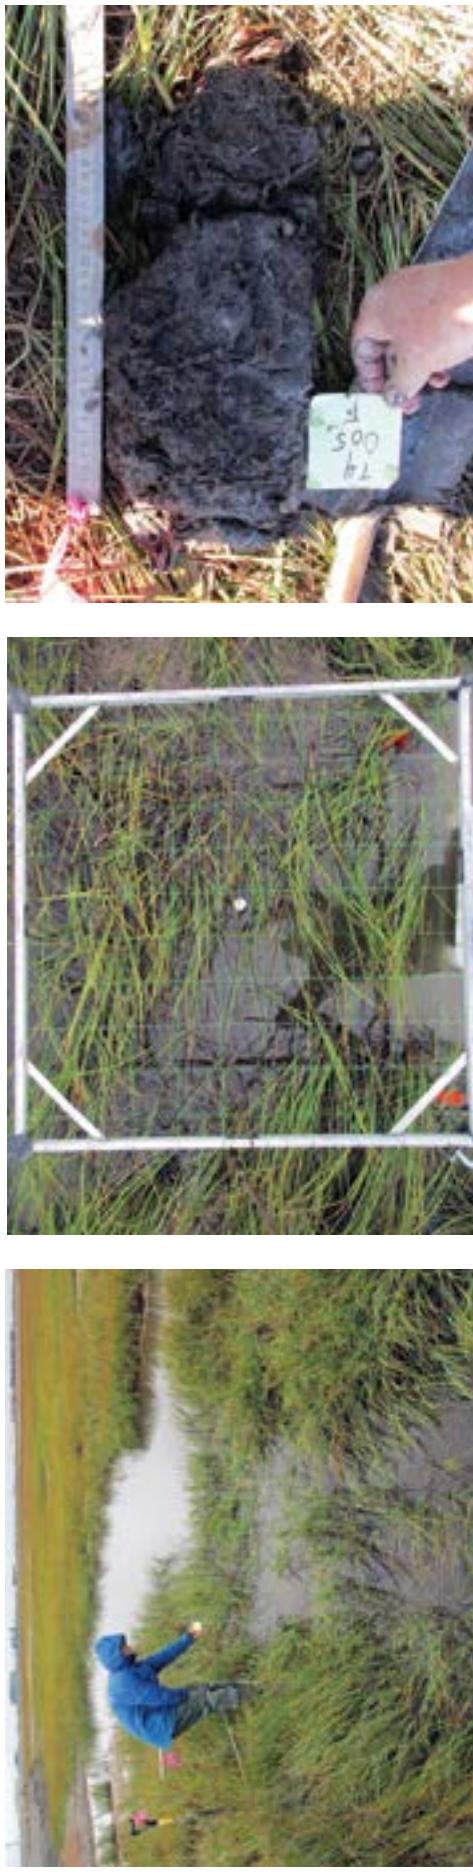
Transect 4, 5 m, polygon trough (T4-005-T). (l-r) site location with 1-m plot marked with wooden corner stakes, plot with 1-m grid, soil plug.

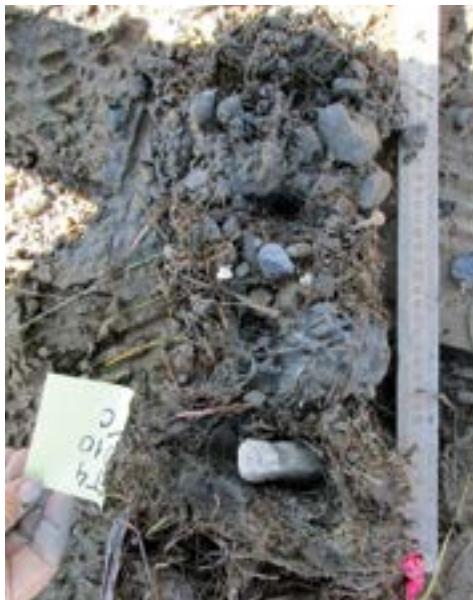
Transect 4, 10 m, polygon center (T4-010-C). (l-r) site location with 1-m plot marked with wooden corner stakes, plot with 1-m grid, soil plug.

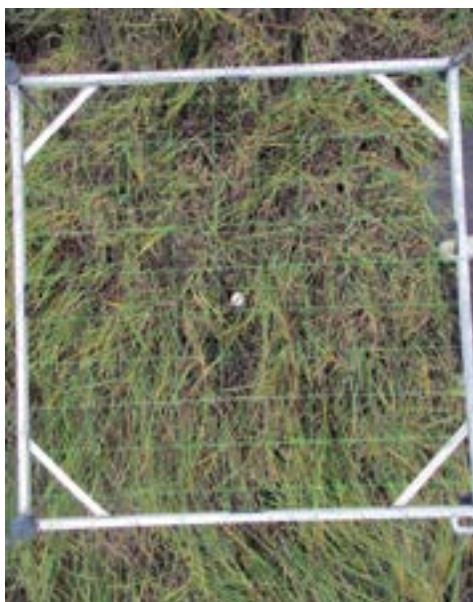
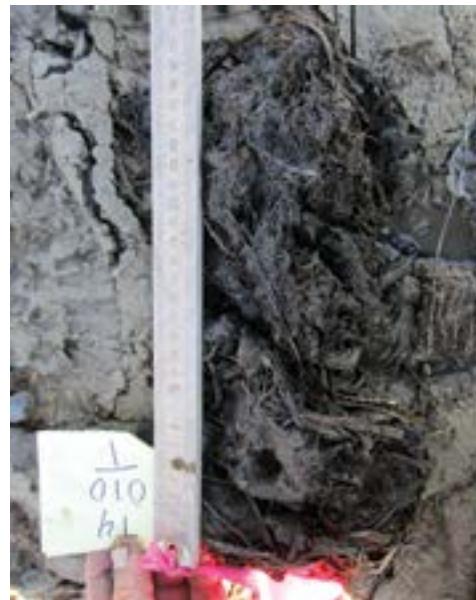
Transect 4, 10 m, polygon center (T4-010-T). (l-r) site location with 1-m plot marked with wooden corner stakes, plot with 1-m grid, soil plug.

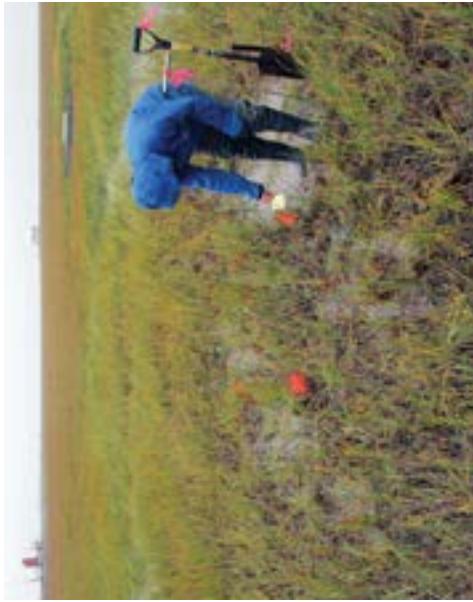
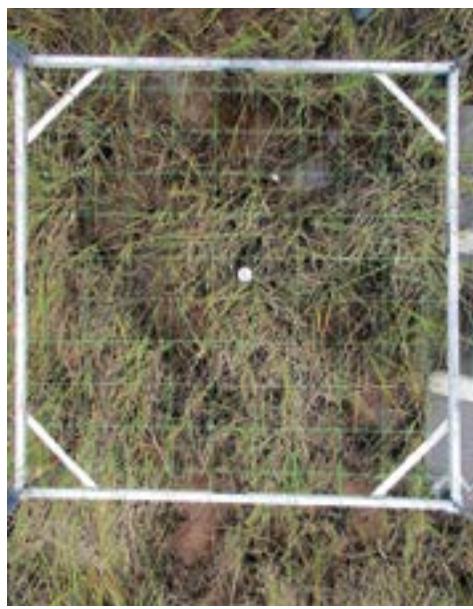
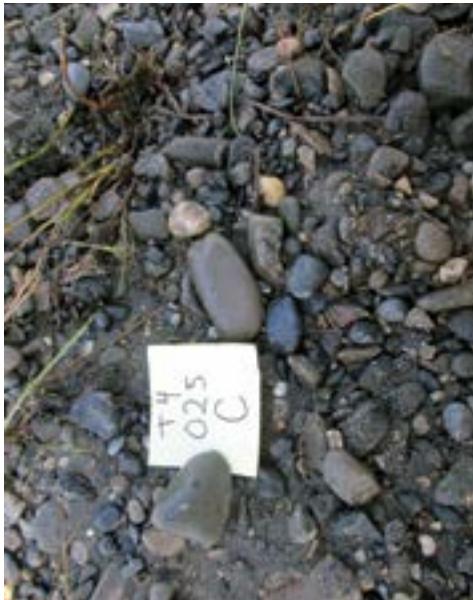
Transect 4, 25 m, polygon center (T4-025-C). (l-r) site location with 1-m plot marked with wooden corner stakes, plot with 1-m grid, no soil sample (gravel).

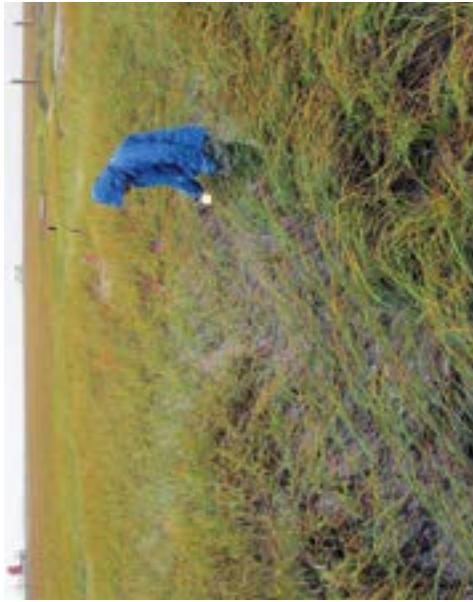
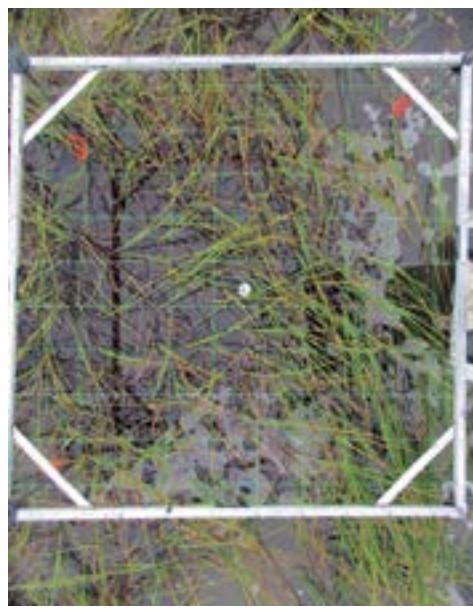
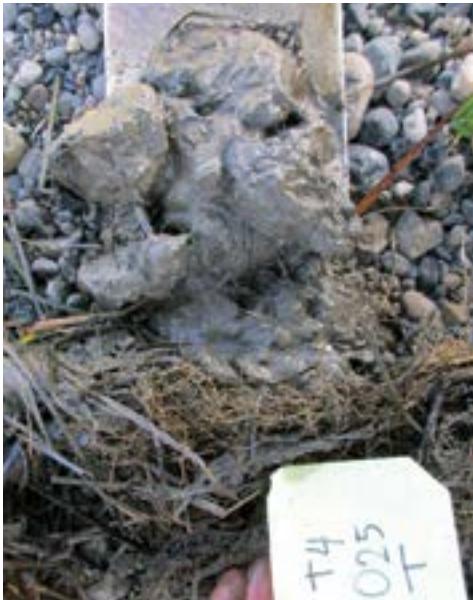
Transect 4, 25 m, polygon trough (T4-025-T). (l-r) site location with 1-m plot marked with wooden corner stakes, plot with 1-m grid, no soil sample (too wet).

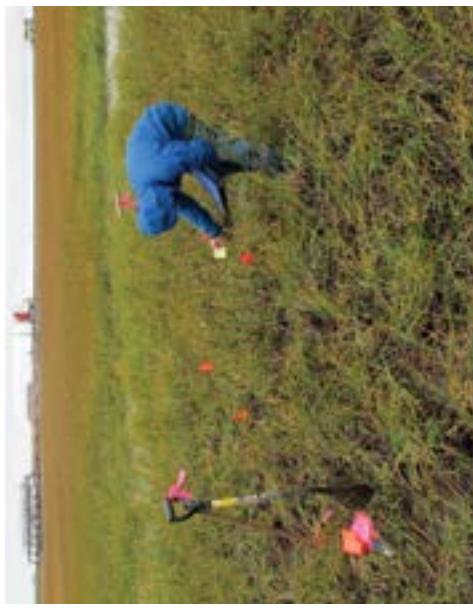
Transect 4: 50 meters from road

Transect 4, 50 m, polygon center (T4-050-C). (l-r) site location with 1-m plot marked with wooden corner stakes, plot with 1-m grid, soil plug.

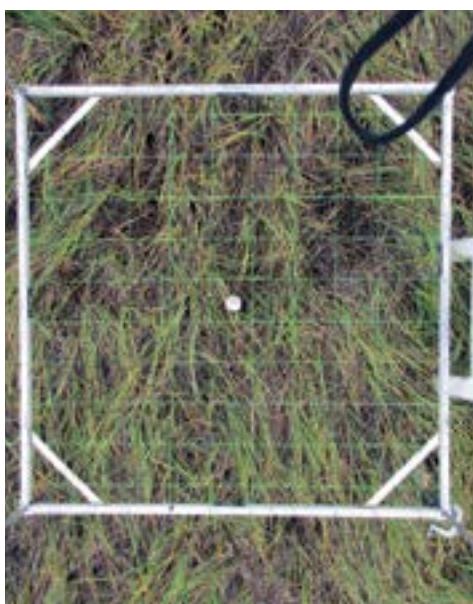
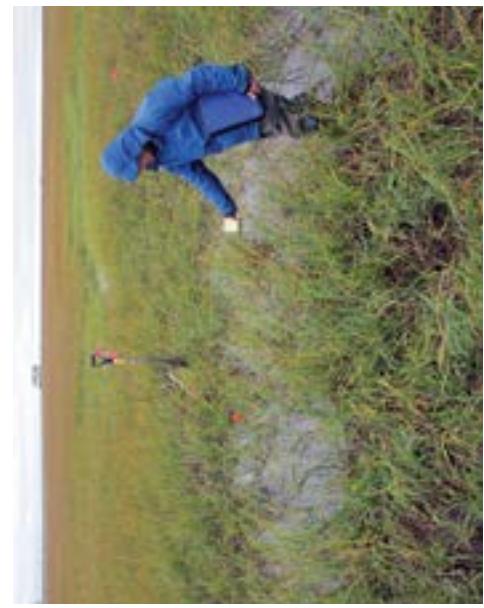
Transect 4, 50 m, polygon trough (T4-050-T). (l-r) site location with 1-m plot marked with wooden corner stakes, plot with 1-m grid, soil plug.

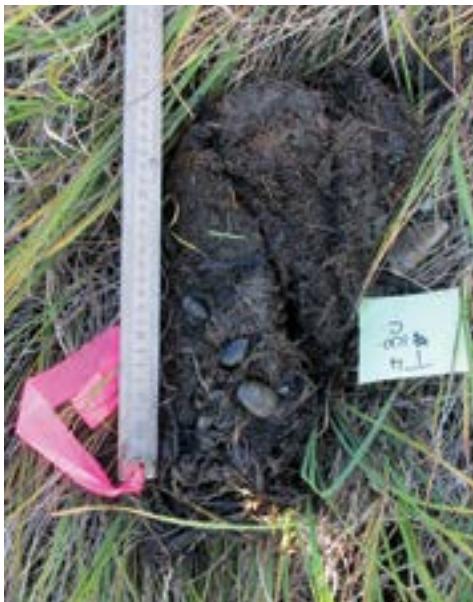
Transect 4: 100 meters from road

Transect 4, 100 m, polygon center (T4-100-C). (l-r) site location with 1-m plot marked with wooden corner stakes, plot with 1-m grid, soil plug.
