ALASKA GEOBOTANY
CENTER DATA REPORT

ROAD EFFECTS AT AIRPORT STUDY SITE, PRUDHOE BAY, ALASKA, SUMMER 2015

AGC 16-01

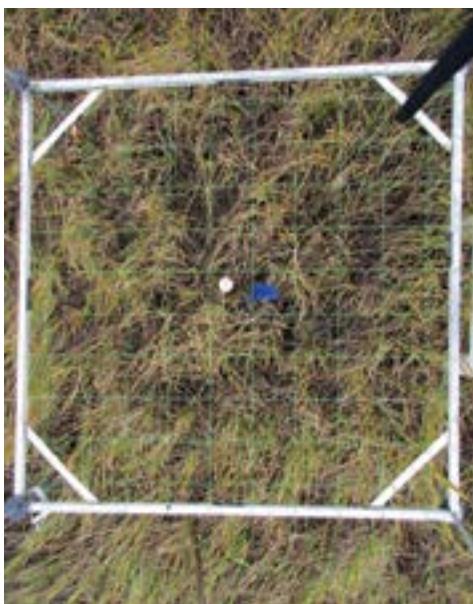
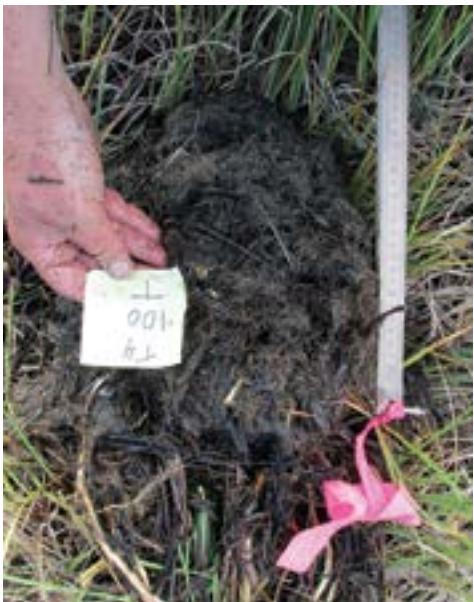
Transect 4, 100 m, polygon center (T4-100-C). (l-r) site location with 1-m plot marked with wooden corner stakes, plot with 1-m grid, soil plug.

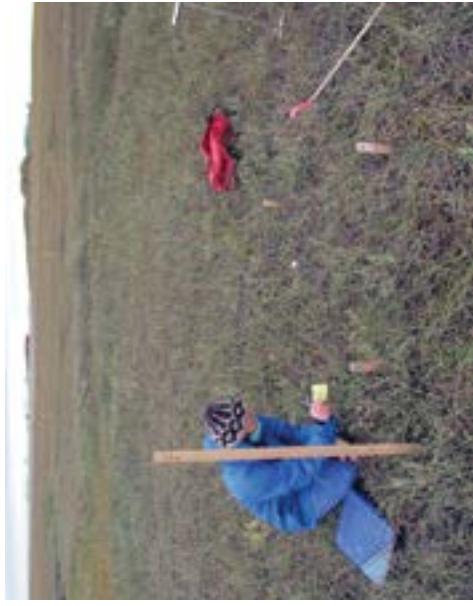
Transect 5: 25 meters from road

Transect 5, 25 m, polygon center (T2-025-C). (l-r) site location with 1-m plot marked with wooden corner stakes, close up of plot, soil plug.

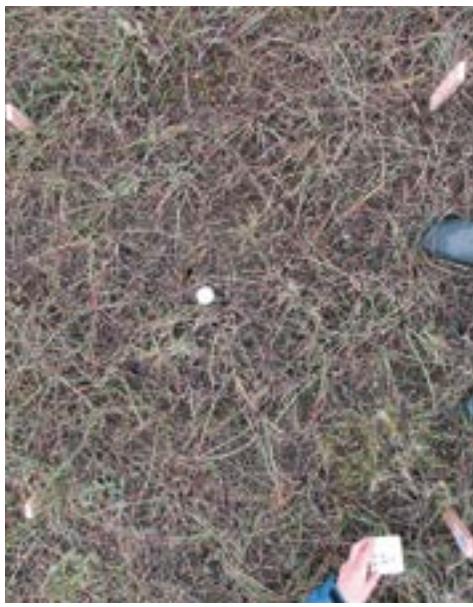
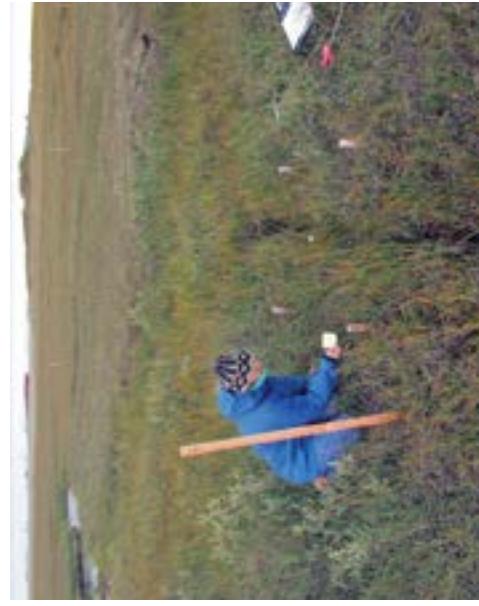
Transect 5, 25 m, polygon trough (T2-025-T). (l-r) site location with 1-m plot marked with wooden corner stakes, close up of plot, soil plug.

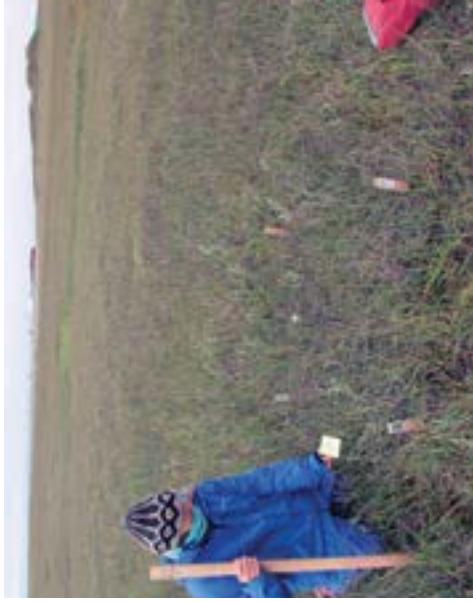
Transect 5: 50 meters from road

Transect 5, 50 m, polygon center (T5-050-C). (l-r) site location with 1-m plot marked with wooden corner stakes, close up of plot, soil plug.

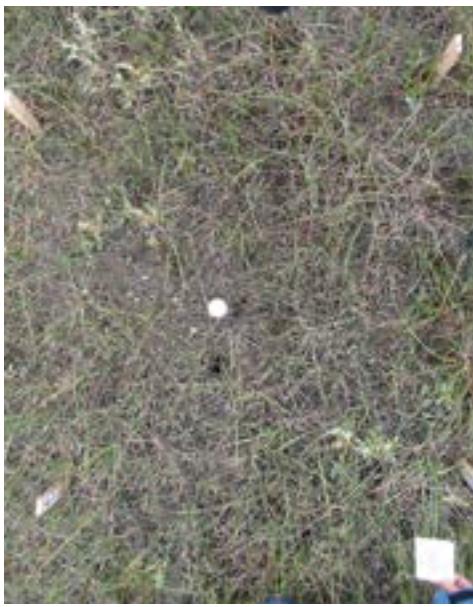
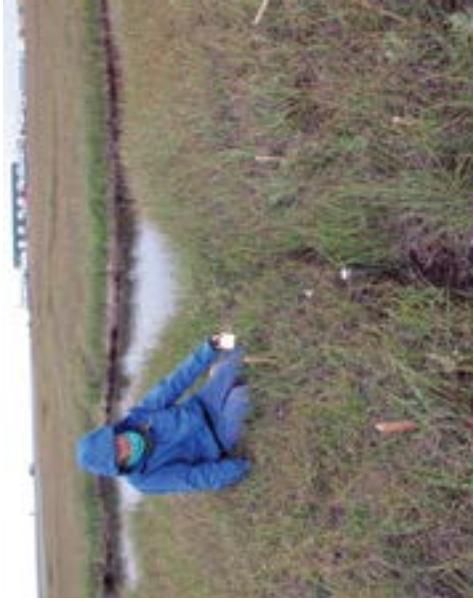
Transect 5, 50 m, polygon trough (T5-050-T). (l-r) site location with 1-m plot marked with wooden corner stakes, close up of plot, soil plug.

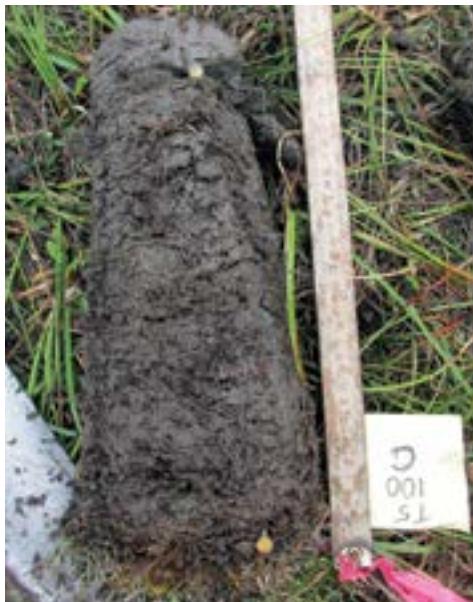
Transect 5: 100 meters from road

Transect 5, 100 m, polygon center (T5-100-C). (l-r) site location with 1-m plot marked with wooden corner stakes, plot with 1-m grid, close up of plot, soil plug.

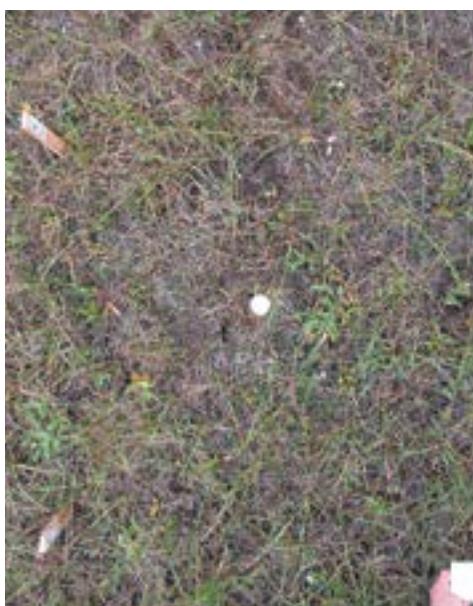
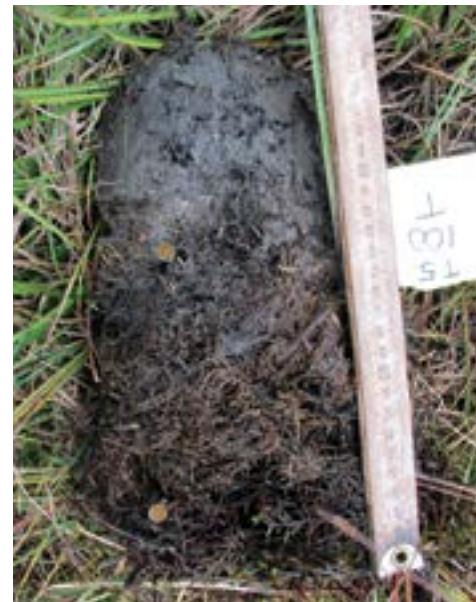
Transect 5, 100 m, polygon trough (T5-100-T). (l-r) site location with 1-m plot marked with wooden corner stakes, close up of plot, soil plug.
