Cumulative impacts of a
gravel road and climate
change in an ice-wedge
polygon landscape,
Prudhoe Bay, Alaska

Skip Walker
University of Alaska Fairbanks

ARCTIC INFRASTRUCTURE
SCIENCE TALK

JANUARY 20, 2020

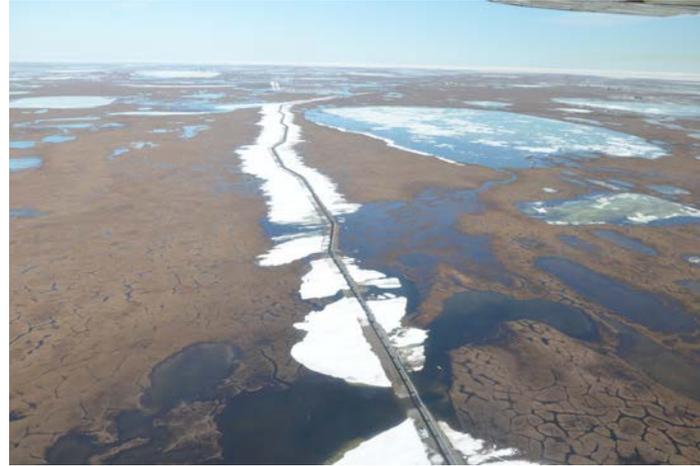
Flooding and snowdrifts

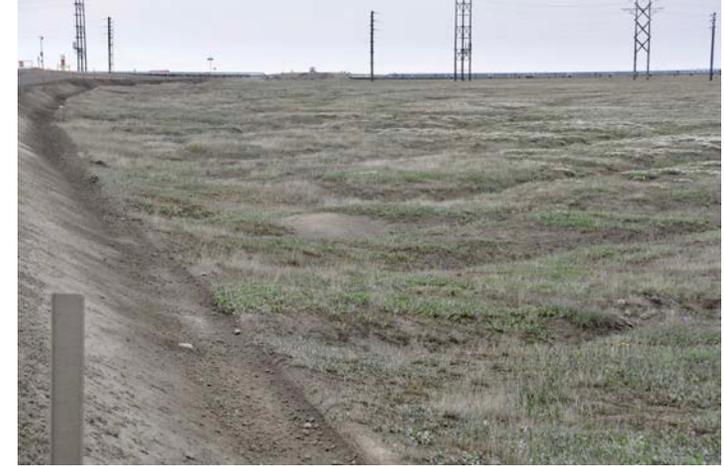
Dust disturbance

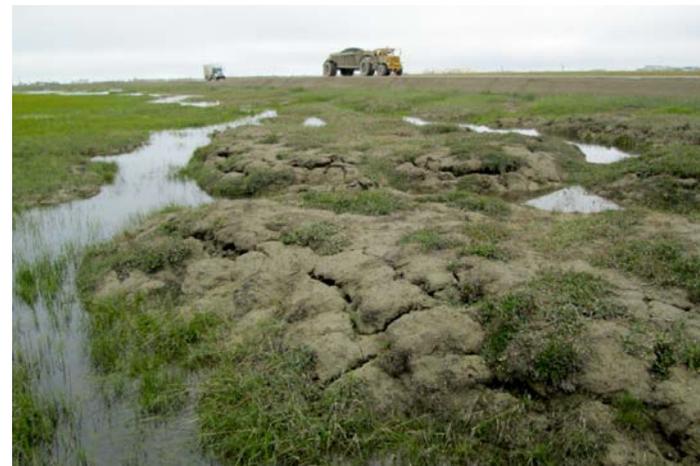
Ice-wedge thermokarst

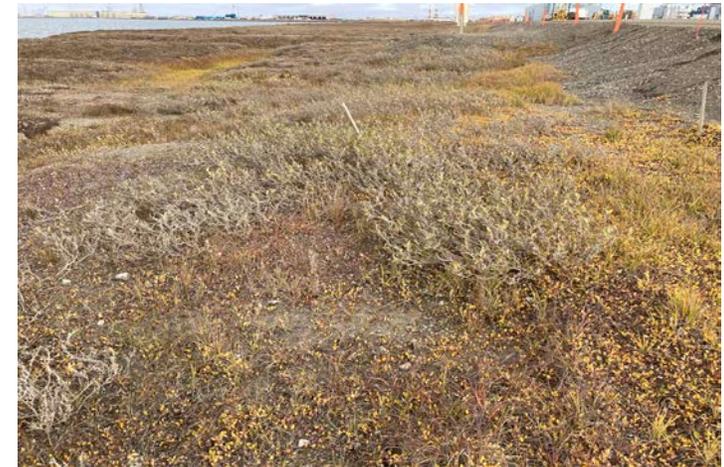
Enhanced shrub growth

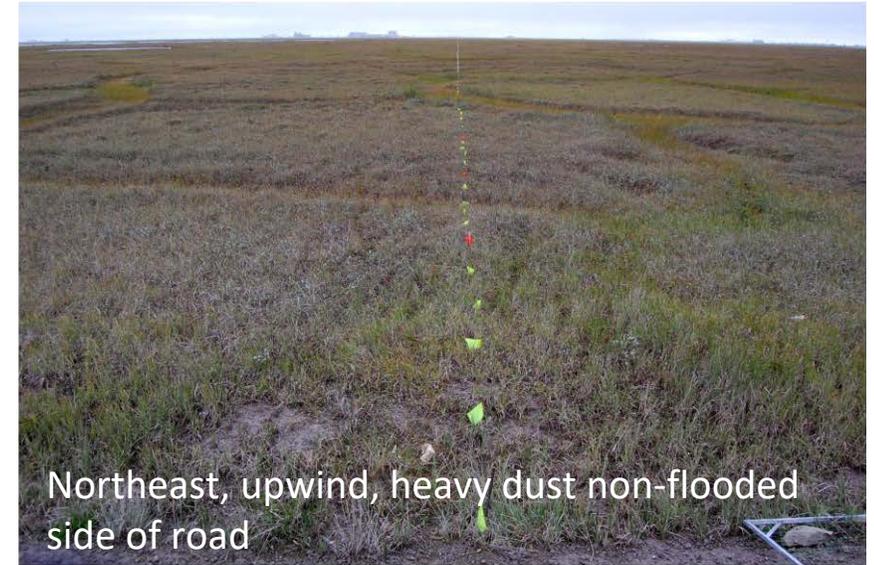
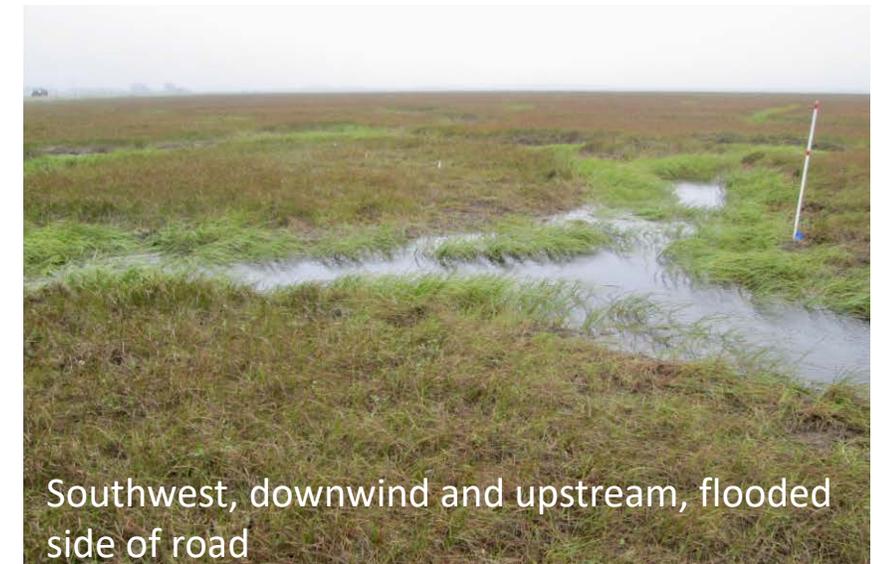
Colleen site (CS): Impacted by climate- and infrastructure-related (change)

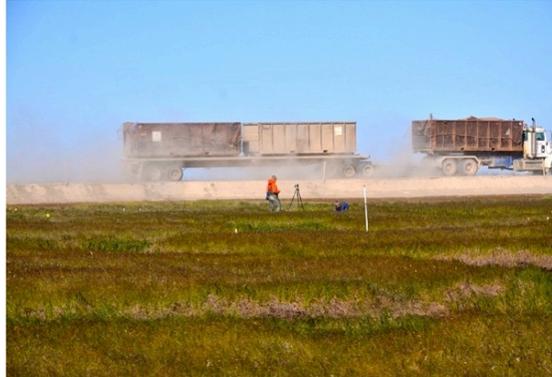
Transects perpendicular to
the road

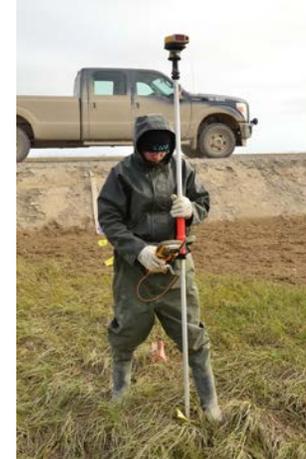
Micro-
topography
surveys

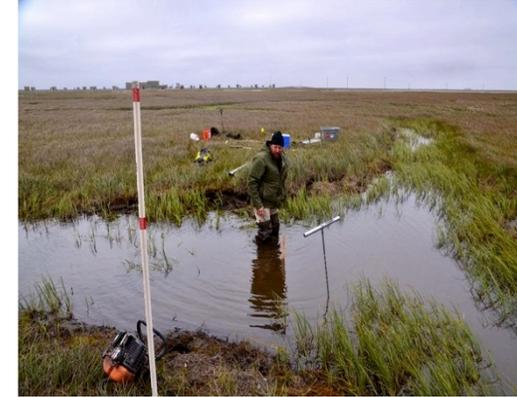
Thaw, water depth,
vegetation height, leaf
area index, NDVI

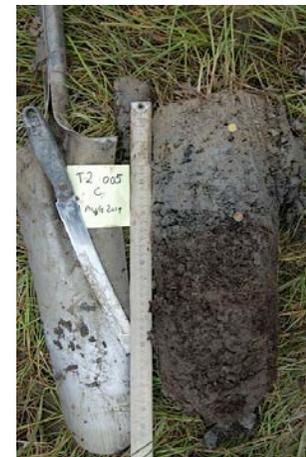
Soil dust layers

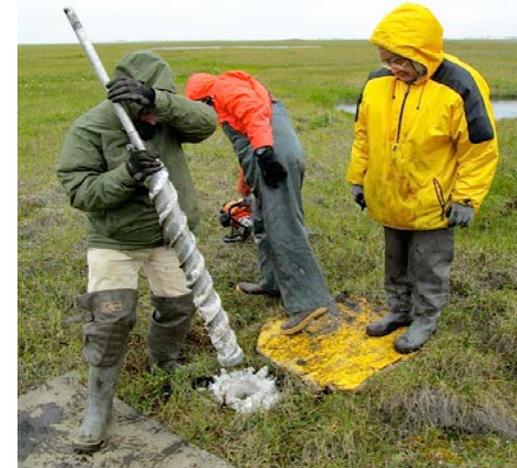
Permafrost cores
